September 25, 2024

Our File No. 1000-043-27

**RE: CQA Summary Letter for
IWMF Search Facility Pad Construction – Mob 1**

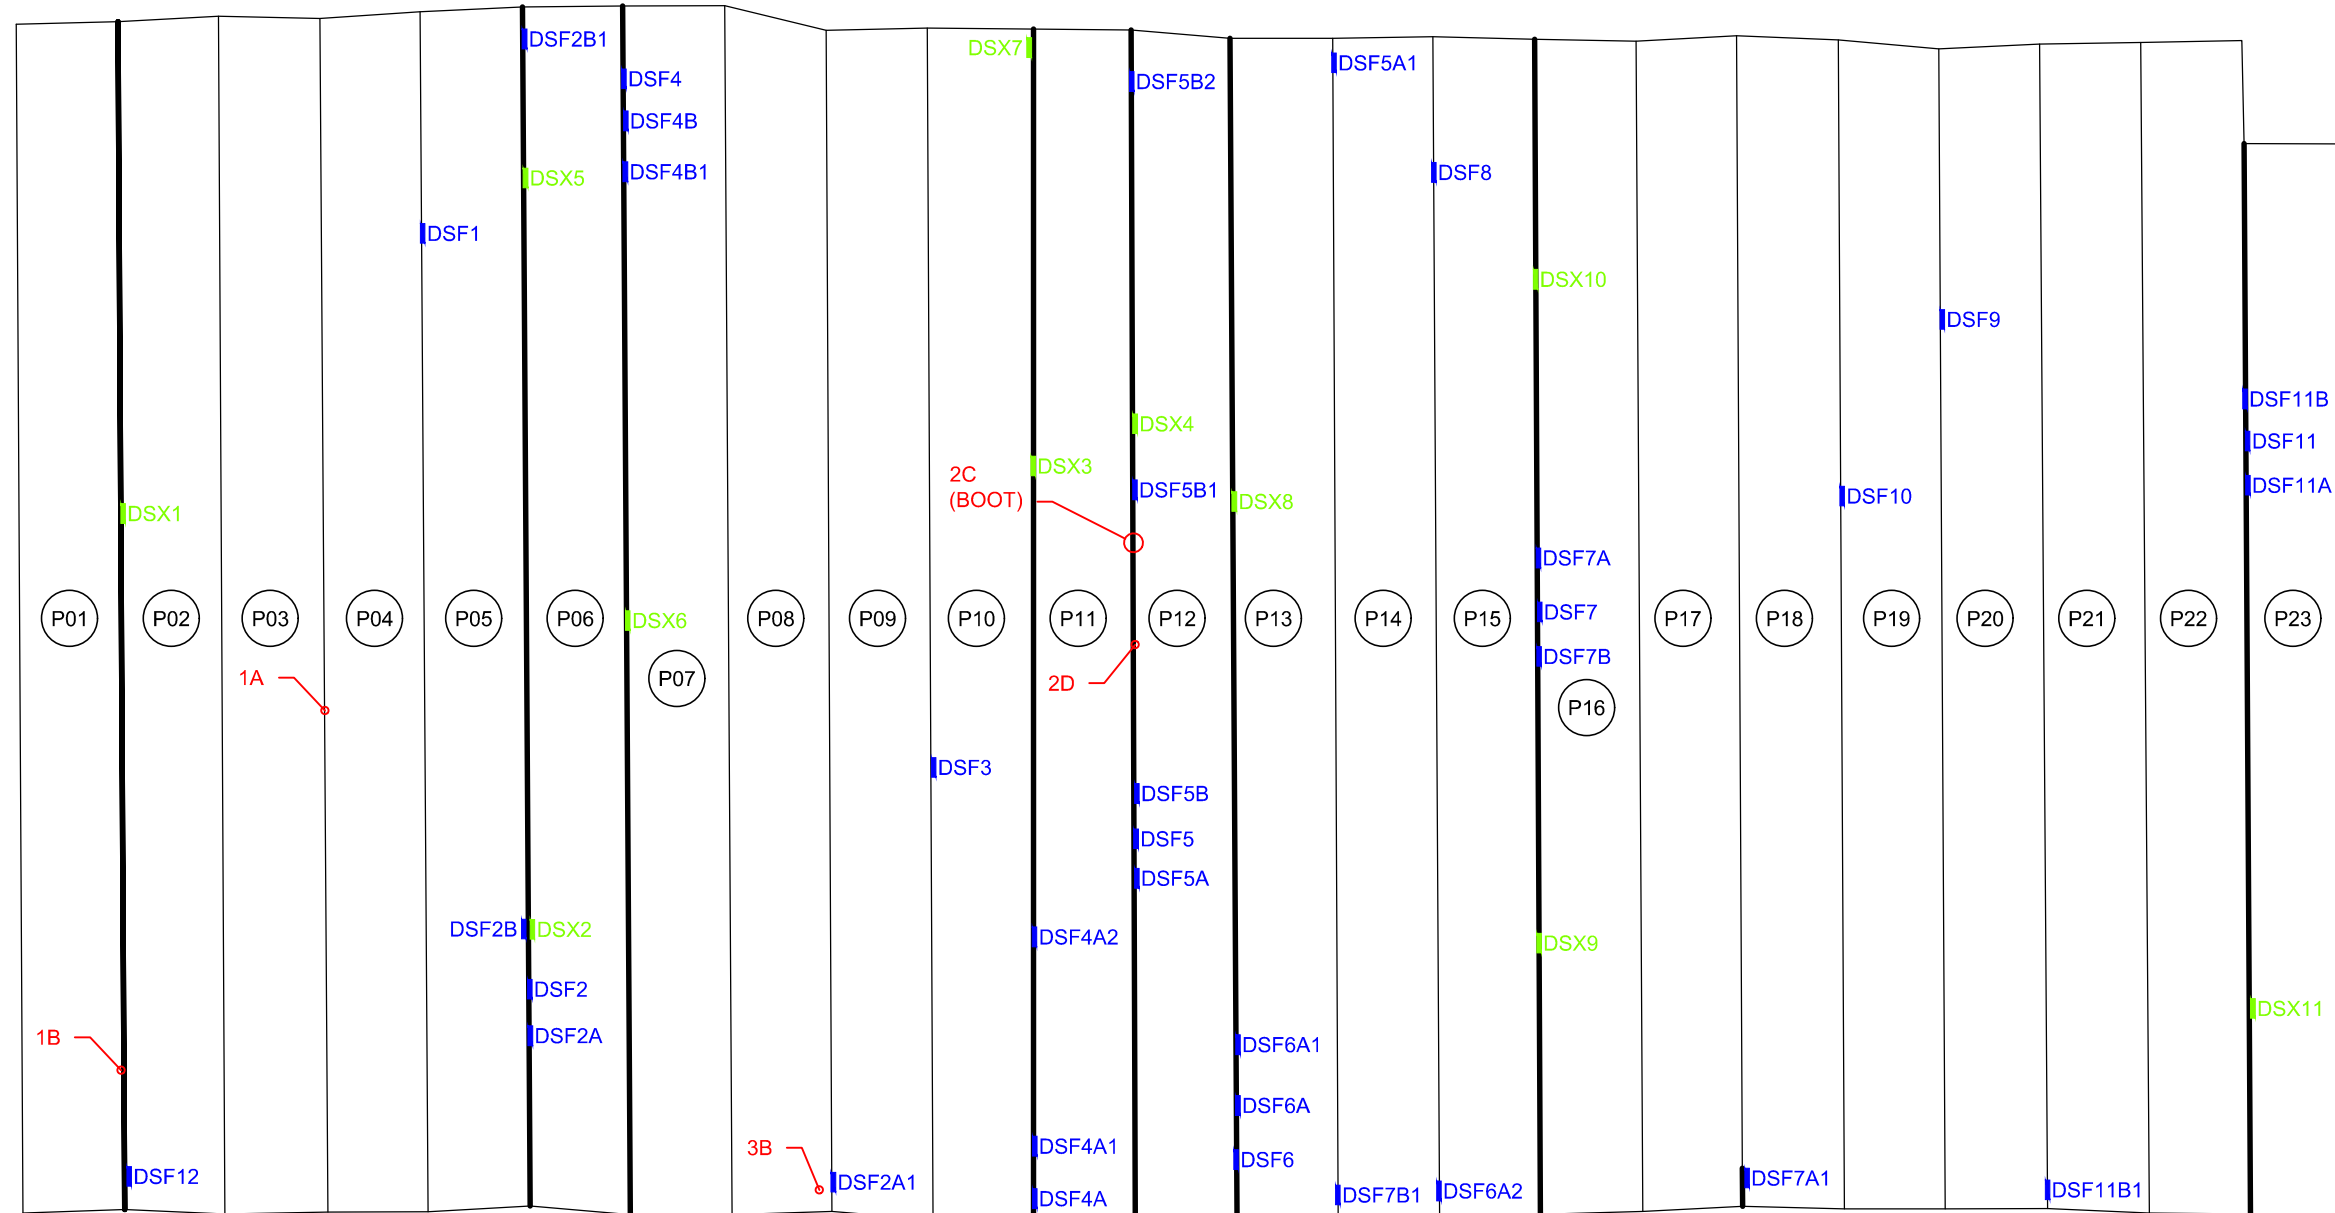
Figure 01
Geomembrane Panel Layout
MOB 1

Deployment of the HDPE liner over the GCL and sand layer subgrade consisted of panels P1 to P23, respectively. The arrangement and designation of the various panels for the HDPE liner are presented on Drawing I attached.

A total of twelve fusion destructive tests (DSF designation) and eleven extrusion tests (DSX designation) were conducted of the HDPE liner. Seven fusion destructive tests failed, and each failed test was traced along the fusion seam activity log to obtain one passing destructive before and after the failed destructive. The failed sections of seams were subsequently extrusion welded and non-destructively tested with the vacuum box. All extrusion destructive tests completed comply with project specifications.
