Subject: Prairie Green IWMF: Search Facility Pad Construction Mob 2 Results

RE: CQA Summary Letter for

IWMF Search Facility Pad Construction - Mob 2/Part A

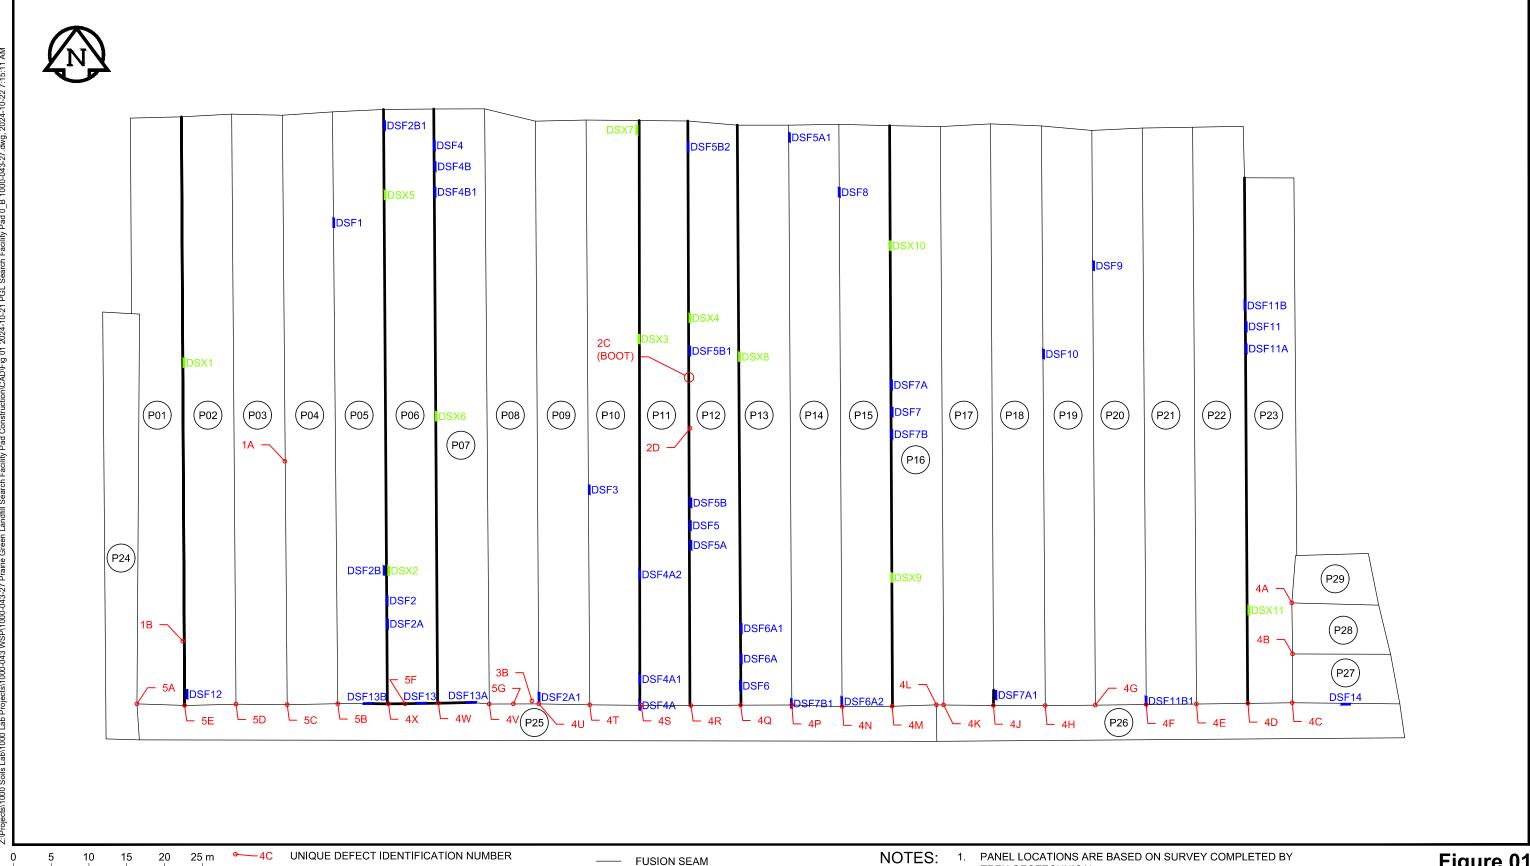
Figure 01 Geomembrane Panel Layout MOB 2 - Part A

Deployment of the HDPE liner over the sand layer subgrade consisted of panels P24 to P29, respectively. The arrangement and designation of the various panels for the HDPE liner are presented on Drawing 1 attached.

A total of two fusion destructive tests (DSF designation) were conducted of the HDPE liner. One fusion destructive test failed, and the failed test was traced along the fusion seam activity log to obtain one passing destructive before and after the failed destructive. The failed sections of seam were subsequently extrusion welded and non-destructively tested with the vacuum box. All extrusion non-destructive tests completed comply with project specifications.
