**WEEKLY MONITORING SUMMARY
MILE POINT 197.4, RIVERS SUBDIVISION DERAILMENT
SOUTHEAST OF ST. LAZARE, MANITOBA**

MONITORING DATES: April 8 to 14, 2019

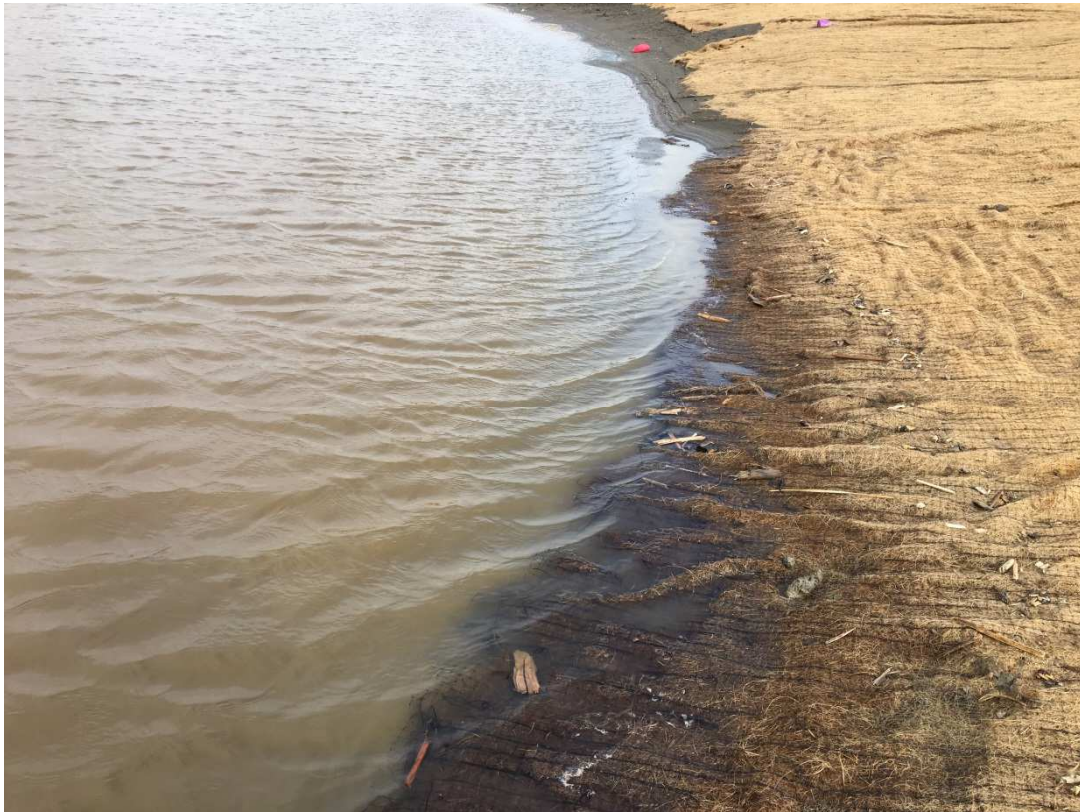
- Surface water inside the berms assessed for hydrocarbon and or/sheen: an organic sheen was observed along the north embankment water's edge. A hydrocarbon sheen was observed in a small area (0.3 m by 0.15 m) located at the bottom of the northwest embankment, directly west of the middle containment boom, with trace amounts of product (3 mm by 3 mm). An absorbent pad used to recover the sheen and product. Two absorbent spill booms were deployed adjacent to the puddle as a precautionary measure.

Photo 1: View of small organic sheen along north embankment.

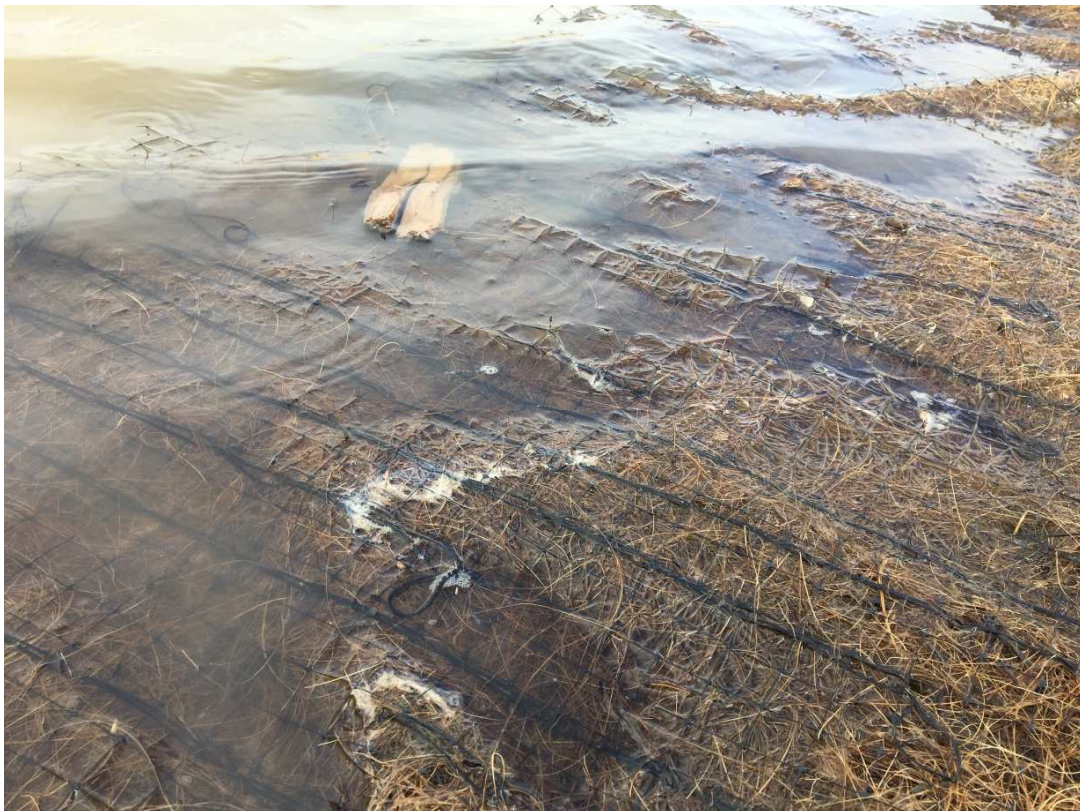
Photo 2: Close up of organic sheen along north embankment

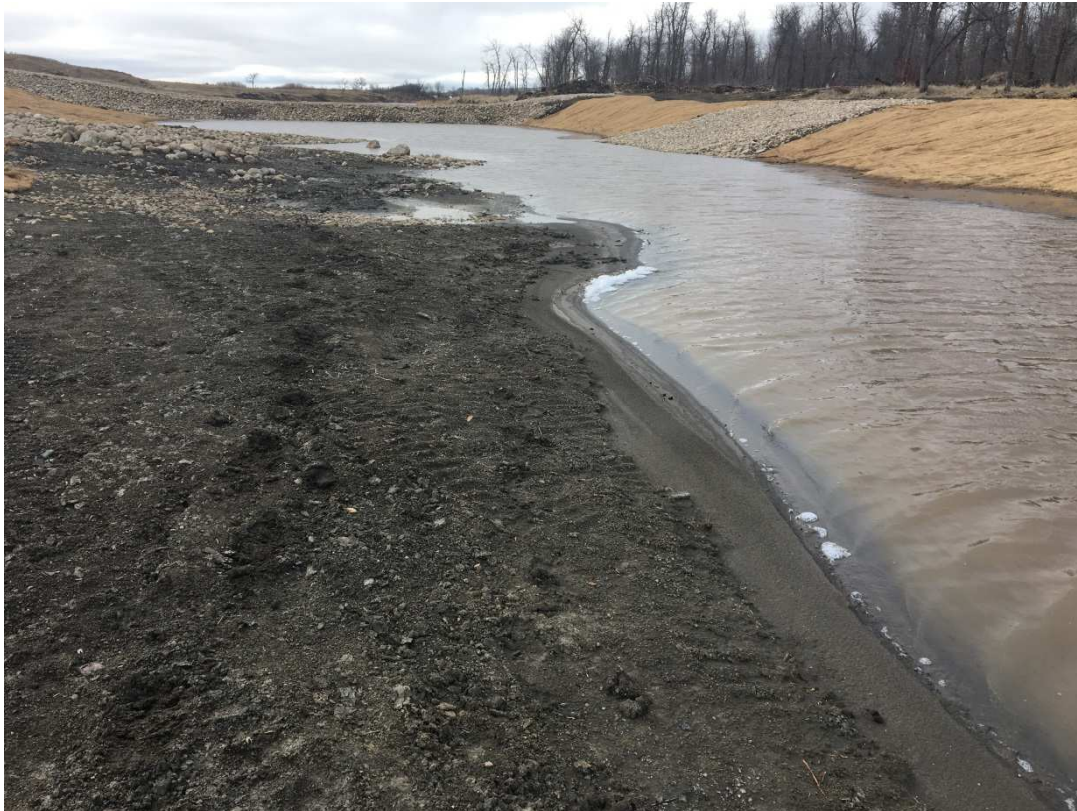
Photo 3: View east towards receding water levels within the oxbow.

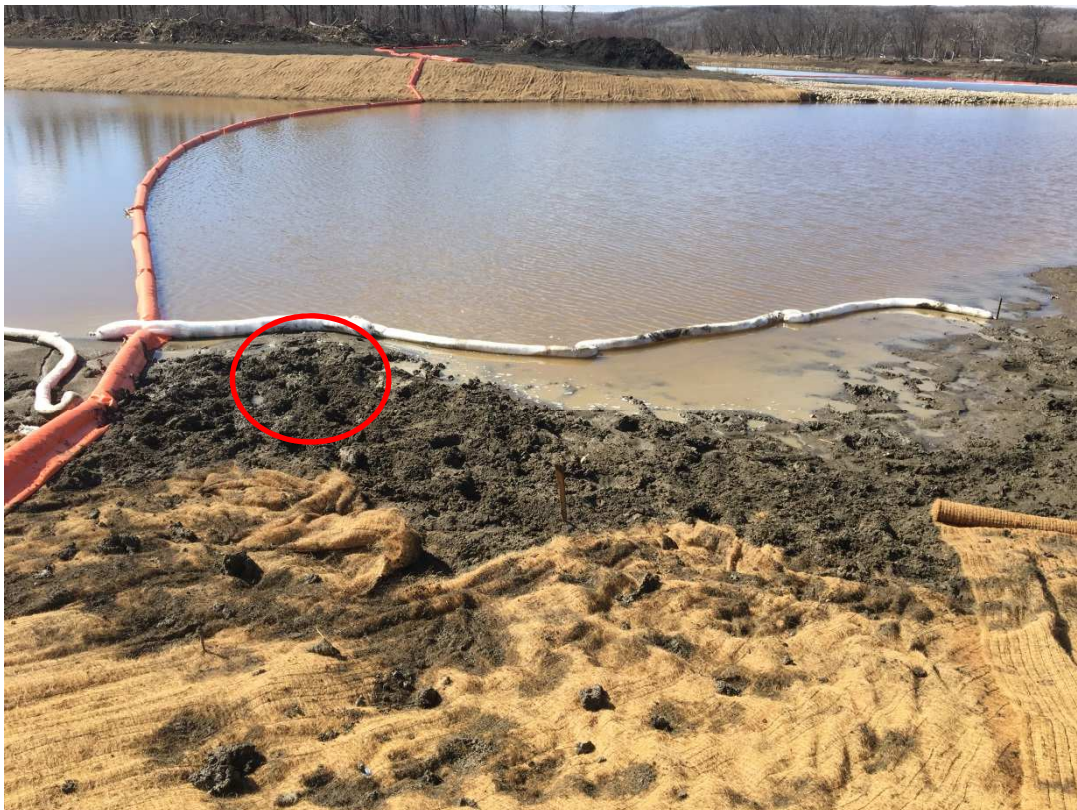
Photo 4: View of small puddle along the northwest embankment with hydrocarbon sheen.

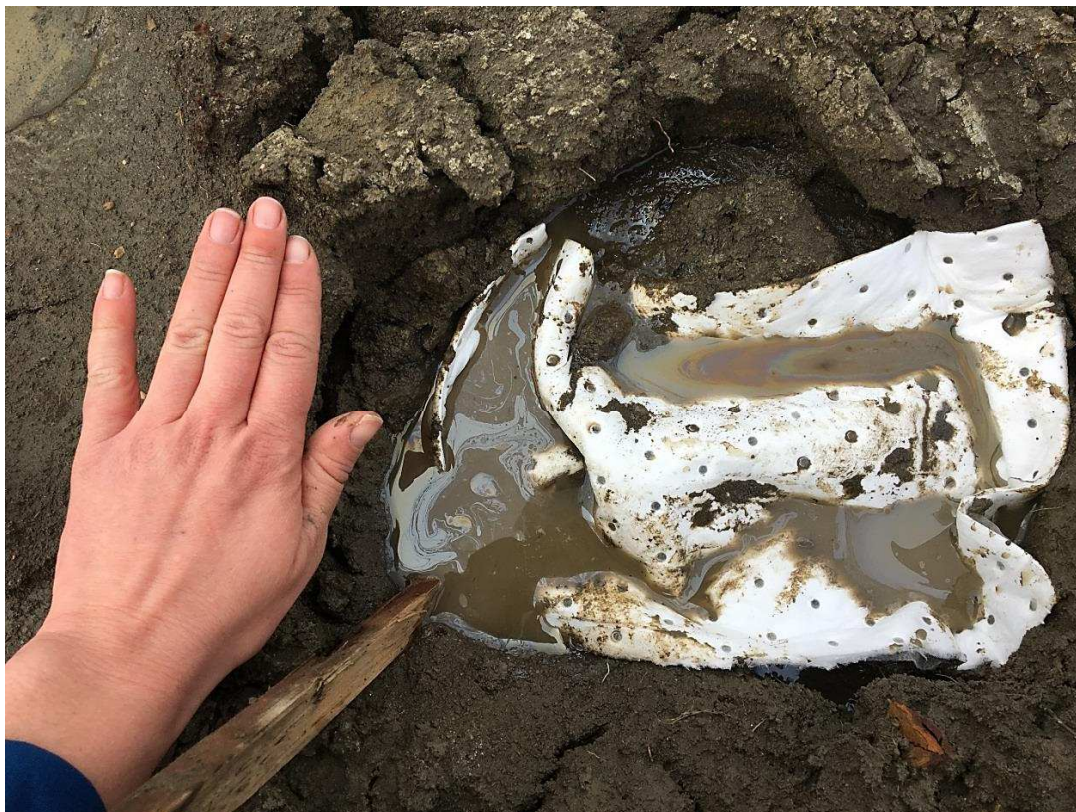
Photo 5: Close up of small puddle and hydrocarbon sheen noted above.

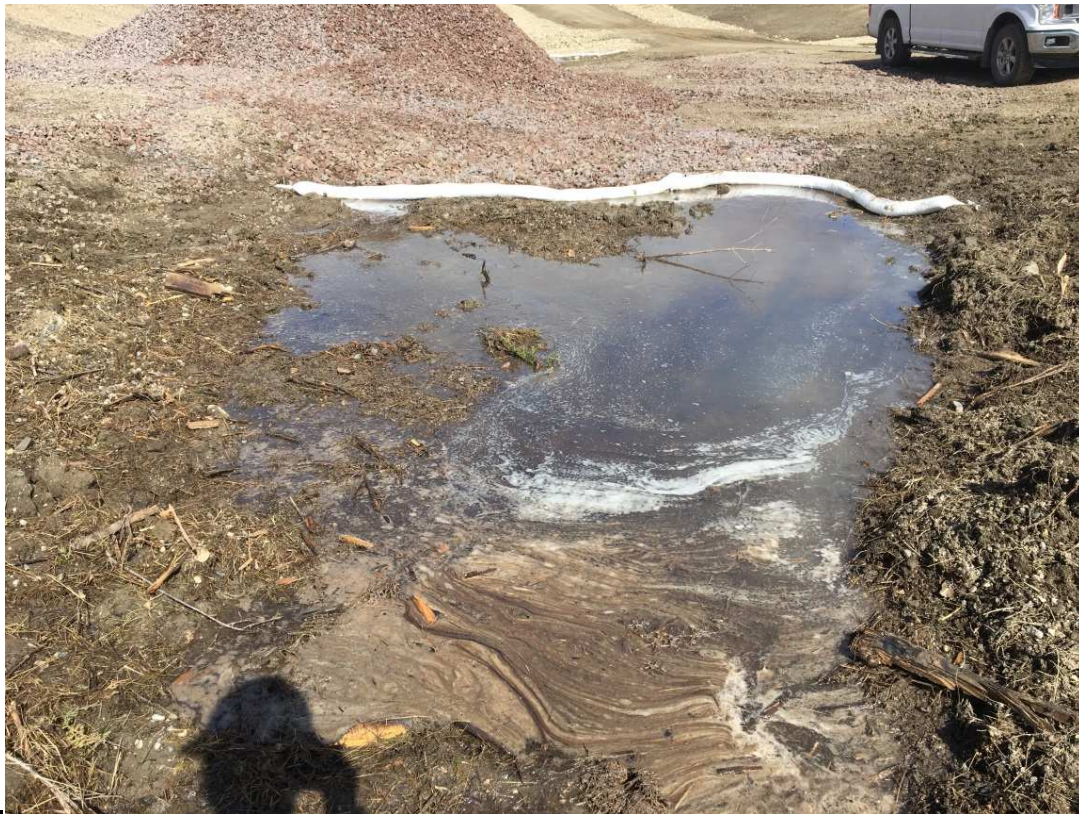
A slight hydrocarbon sheen was observed in the small area of pooling water north of the tracks previously identified in past visits at 14 U 342138 / 5581158. Absorbent pads (4) were placed in the water to remove the sheen and then transferred to a hazmat bag for later off-Site disposal; this area has improved since last visit but a slight sheen was still documented and address.

Photo 6: View of pooling water with slight hydrocarbon sheen north of tracks.

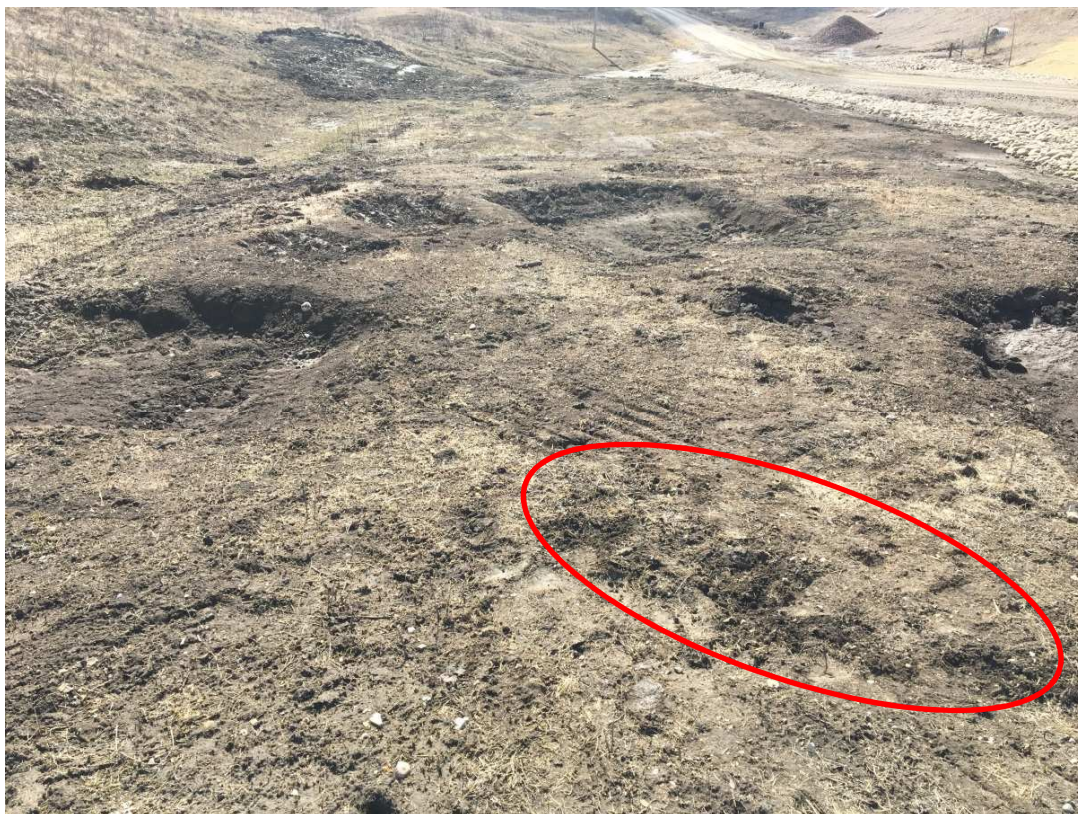
Photo 7: View east towards small traces of product on ground surface north of the grid road that were removed.

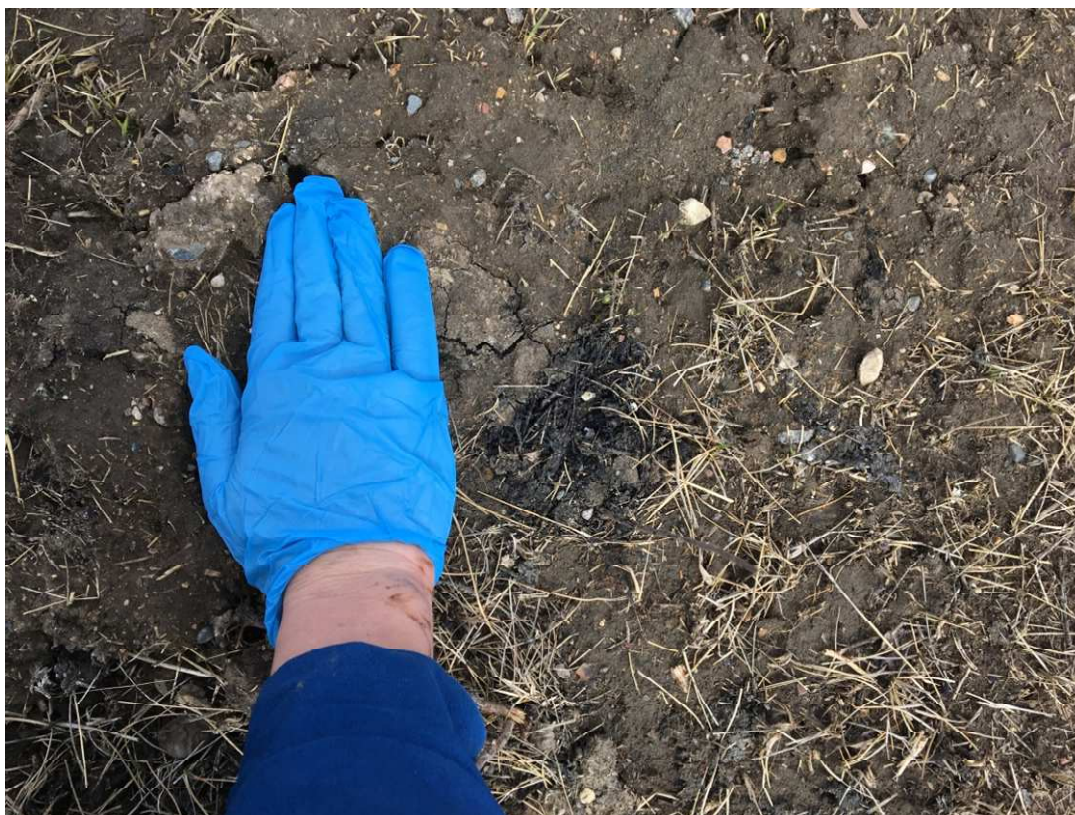
Photo 8: Close up of small residual product spots on ground surface north of grid road.

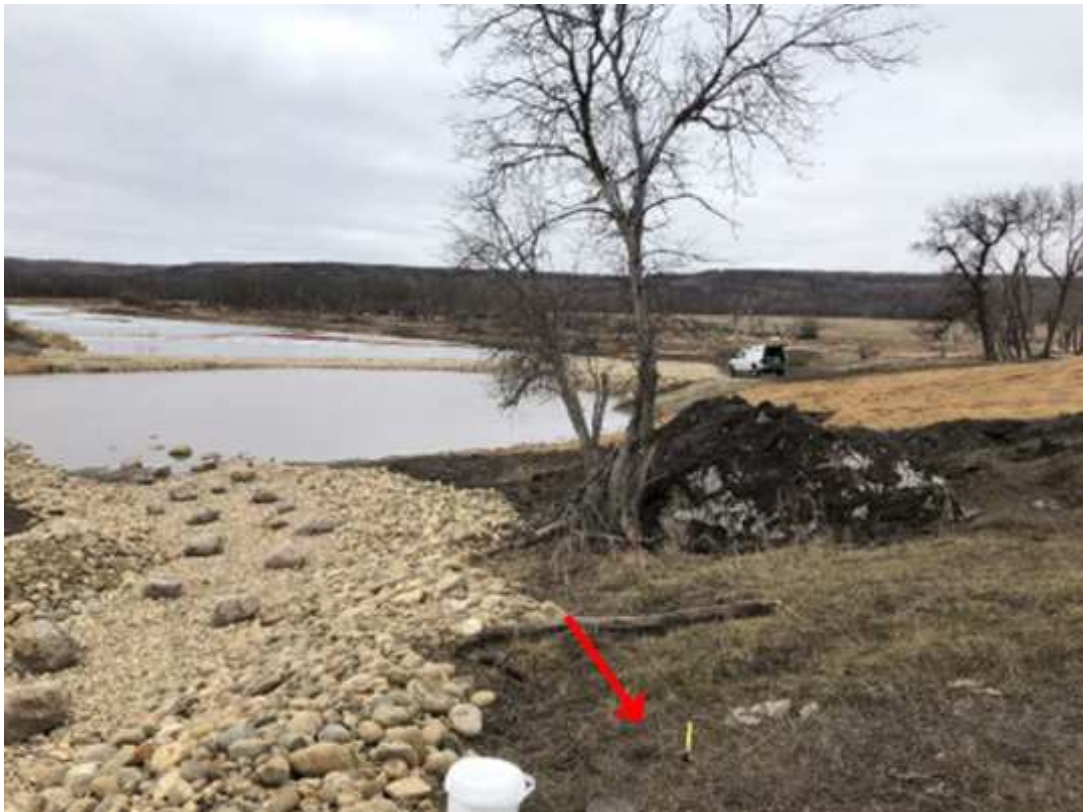
Photo 9: Location of two small impacted spots east of the intermodal containers.

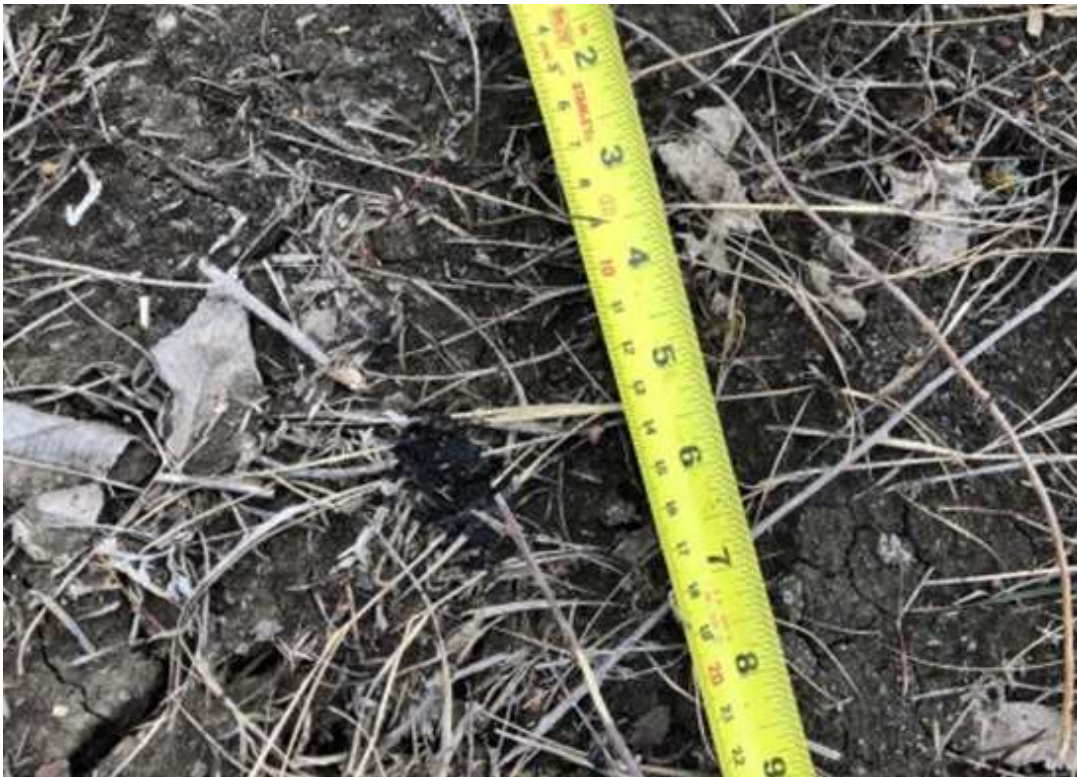
Photo 10: Example of small product spot observed in area shown in Photo 9.

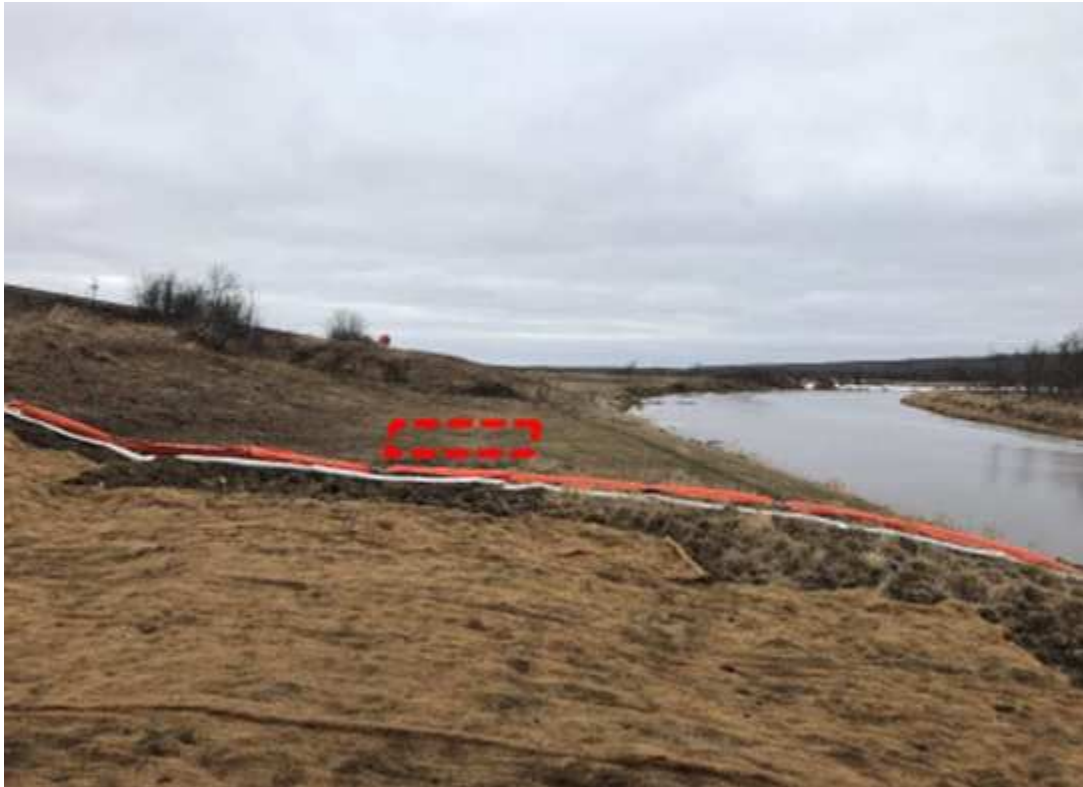
Photo 11: View east towards east boom where five small spots observed.

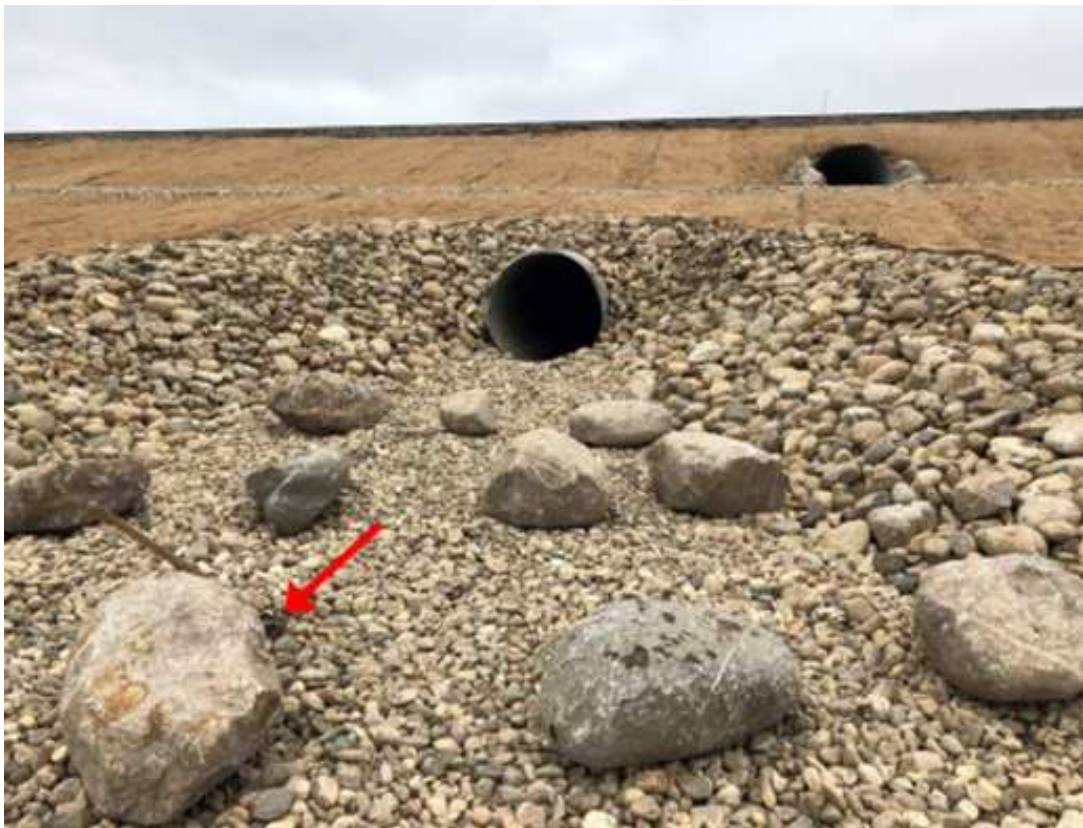
Photo 12: Location of river rocks with observed product downslope of the east culvert.

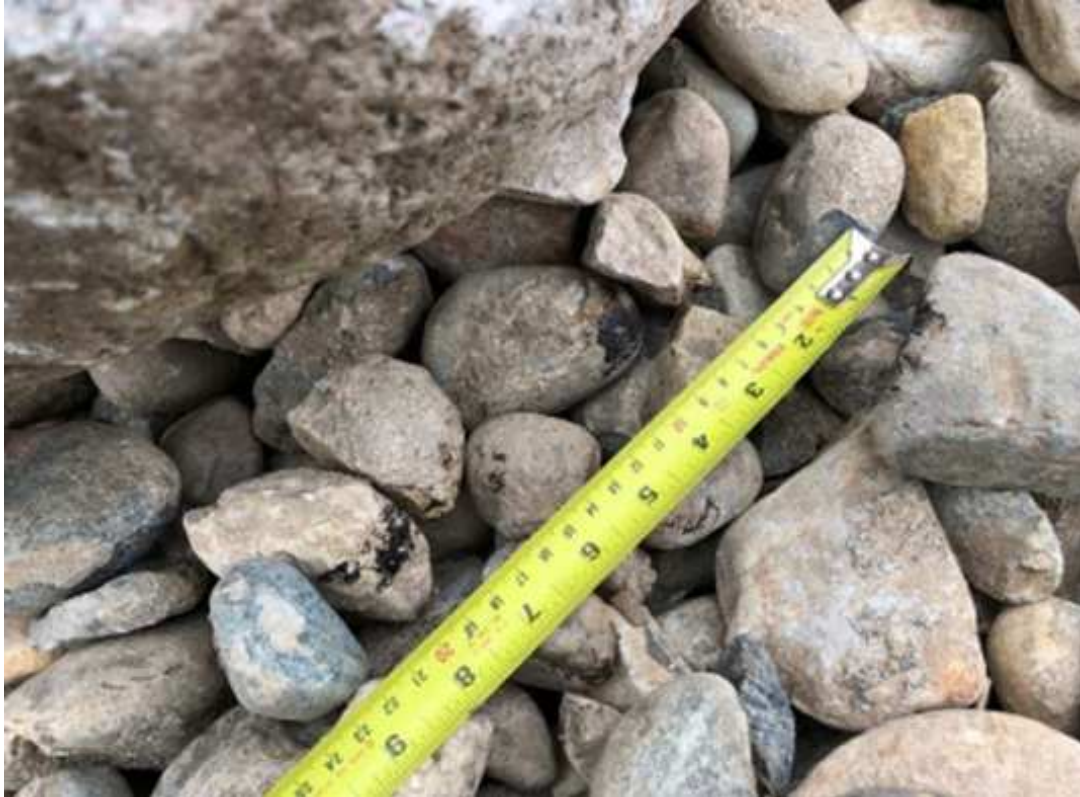
Photo 13: River rocks with small amount of product on them (location shown in Photo 12).

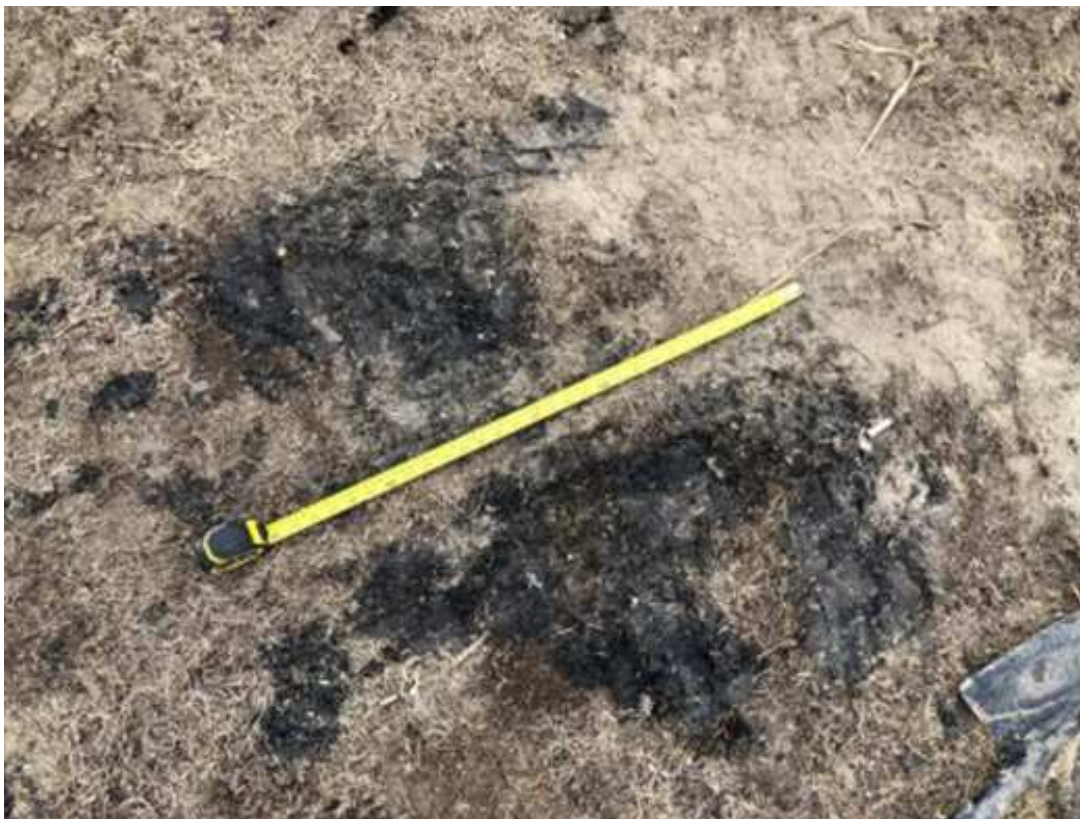
Photo 14: Product spots observed in south shearing area.

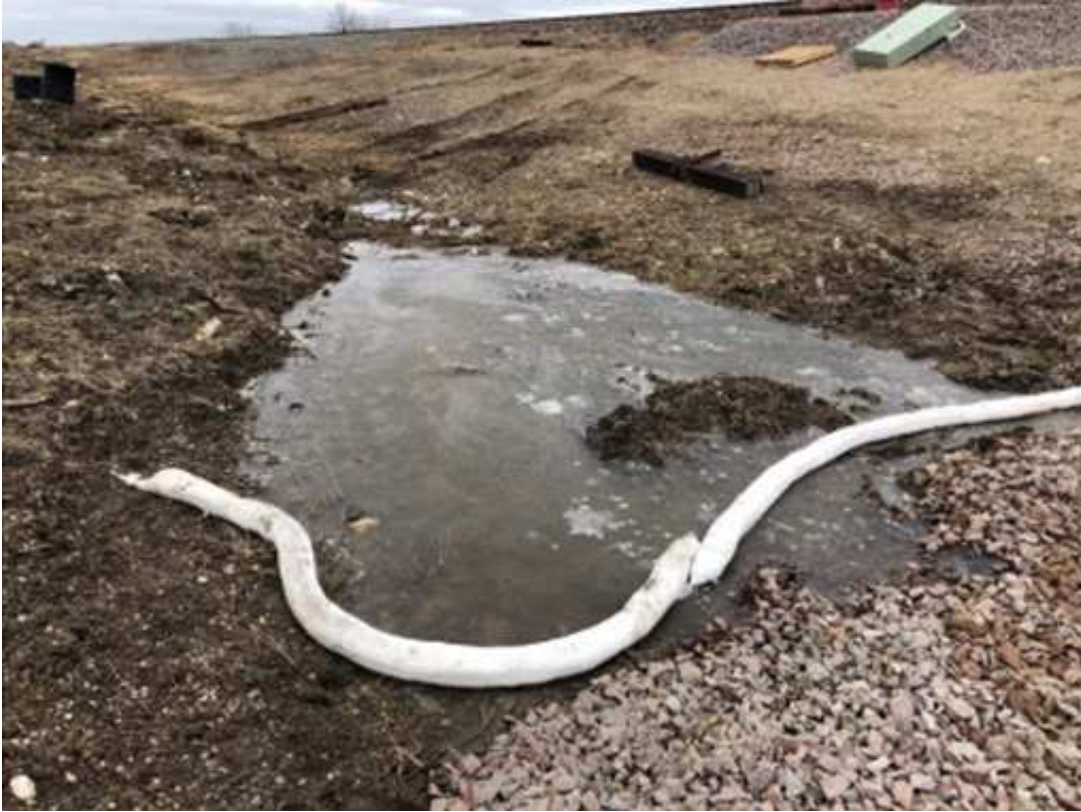
Photo 15: View to the east of the puddle located adjacent to the east culvert on the north side of the tracks.

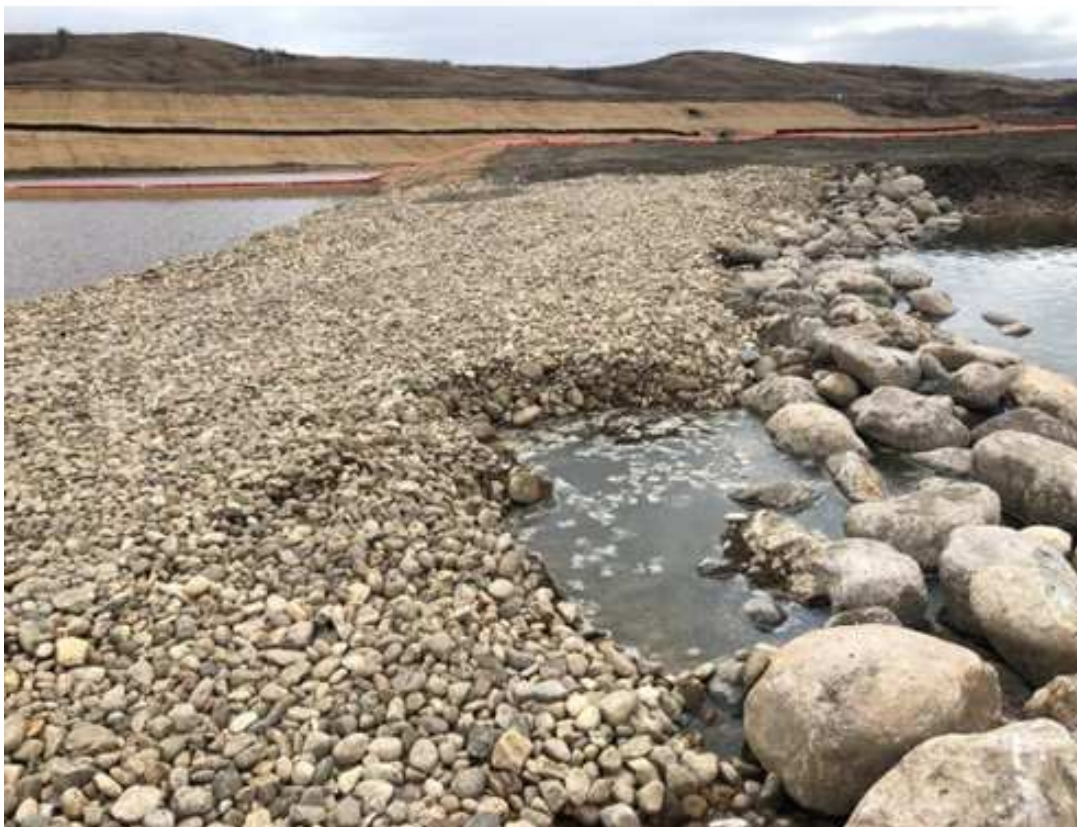
Photo 16: Area of subsidence within the south berm.

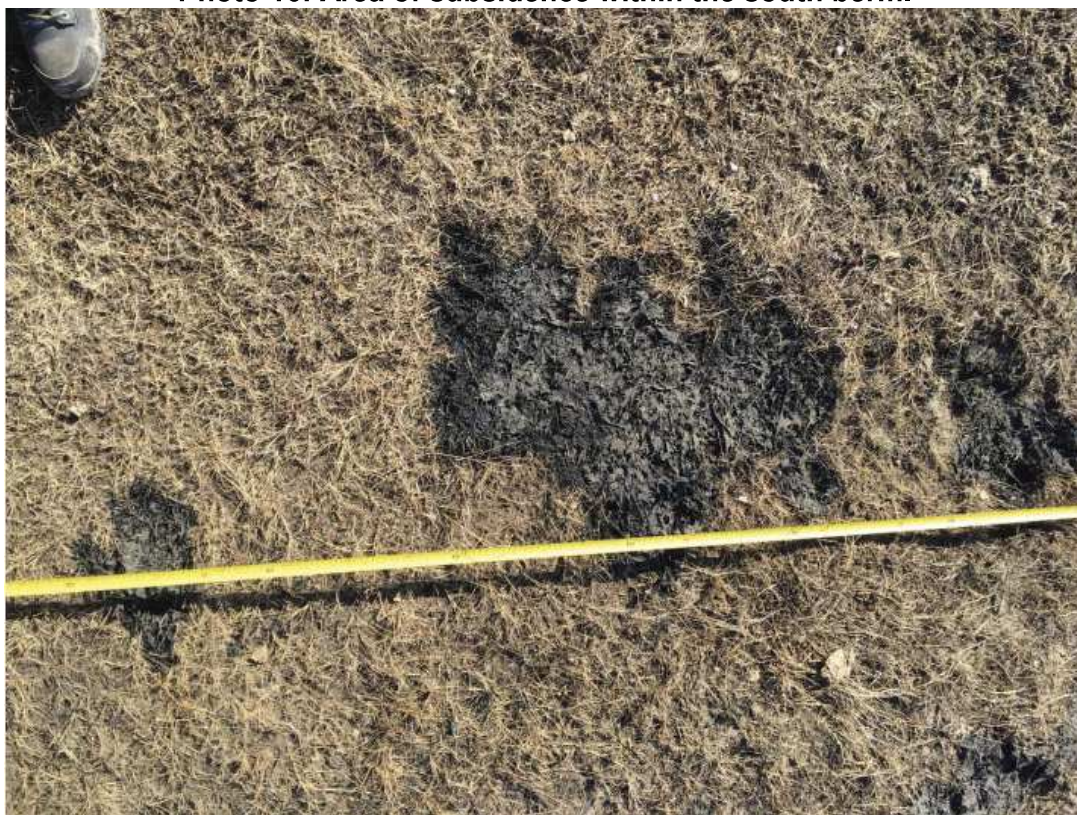
Photo 17: Example of product spot observed within former staging area north of the tracks.

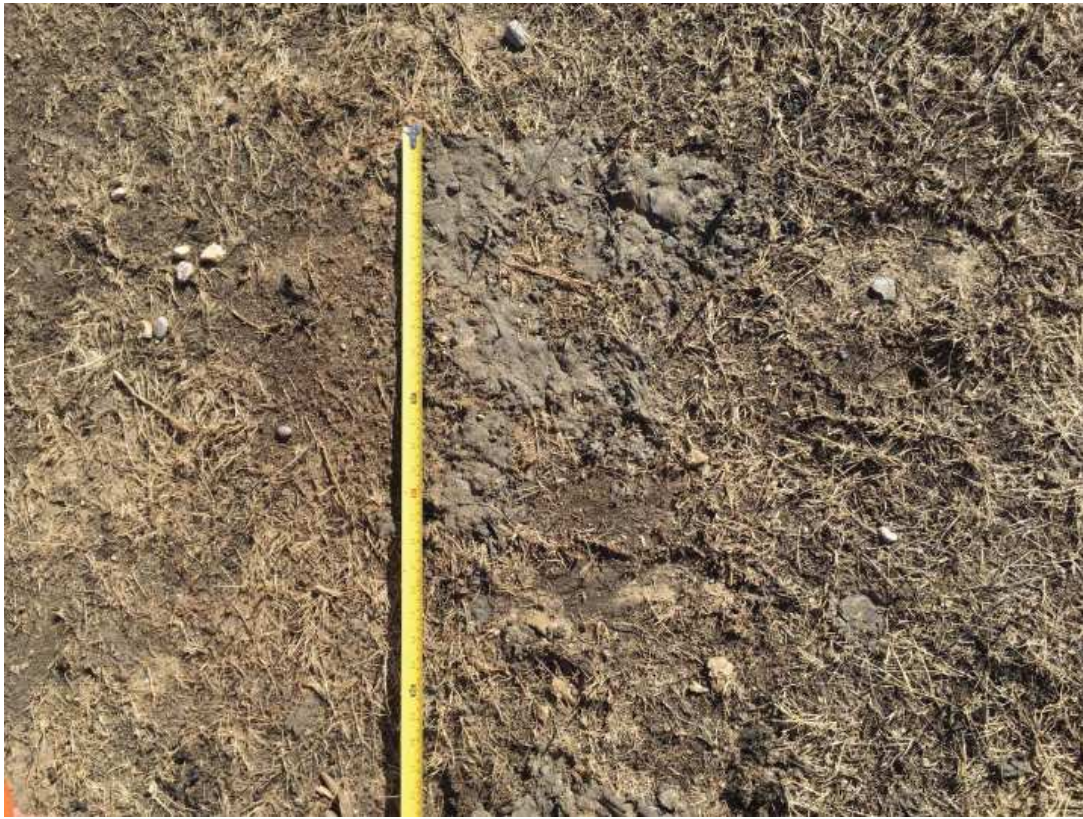
Photo 18: Example of product spot observed within former staging area north of the tracks.

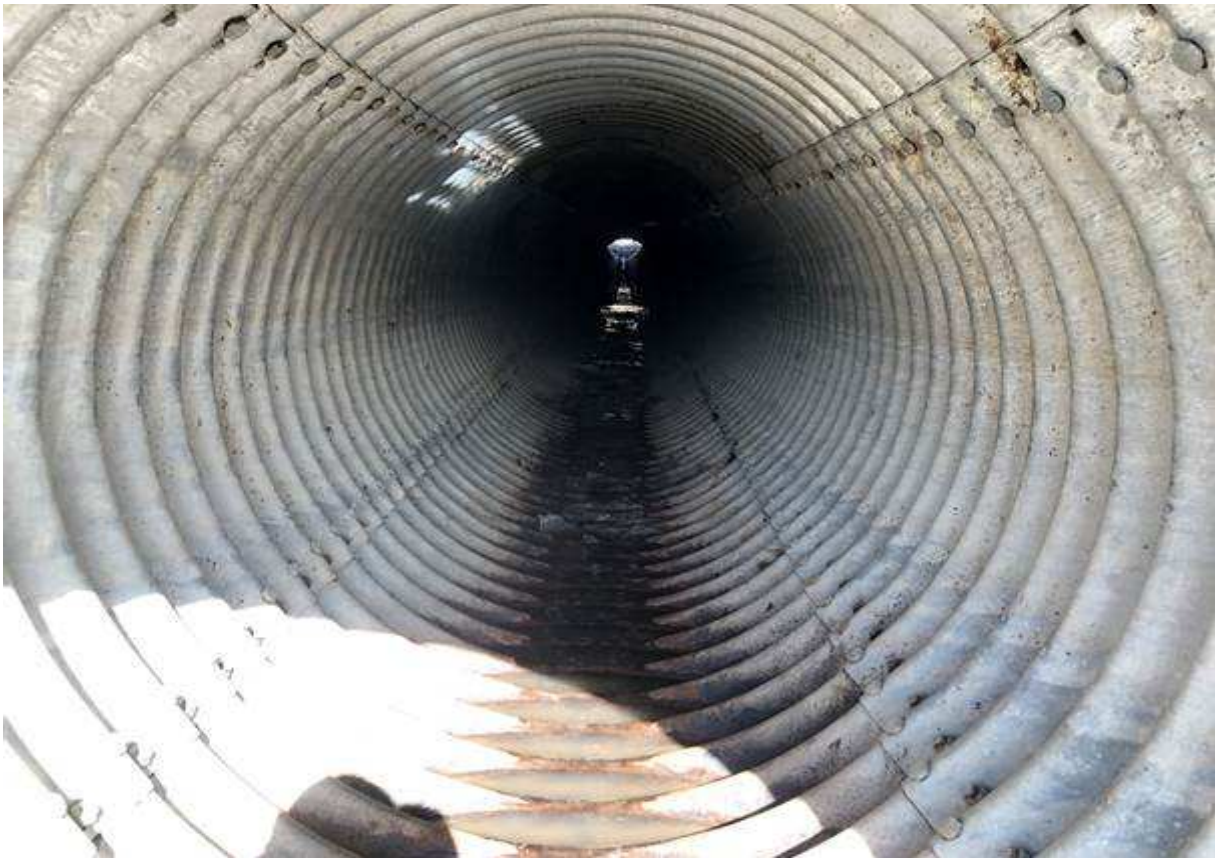
On Saturday, April 13, 2019, following CN's communication with MSD of potential product within the east culvert, Matrix Solutions mobilized to the Site. Due to the culvert being a confined space, a full assessment could not be completed, but observations were made from either end of the culvert. Hydrocarbon staining was observed around the joint connecting the 4-piece culvert where surface water is able to enter. Standing water was observed at the mid-point of the culvert where a bow in the culvert was observed. At the time of inspection, there was no outflow of water from the culvert. As a precautionary measure, an absorbent boom and pads were placed at the south end of the culvert.

Photo 20: April 13, 2019 view looking north from the south end of the east culvert. Standing water is present in the middle of the culvert; no product or hydrocarbon sheen observed in surface water.

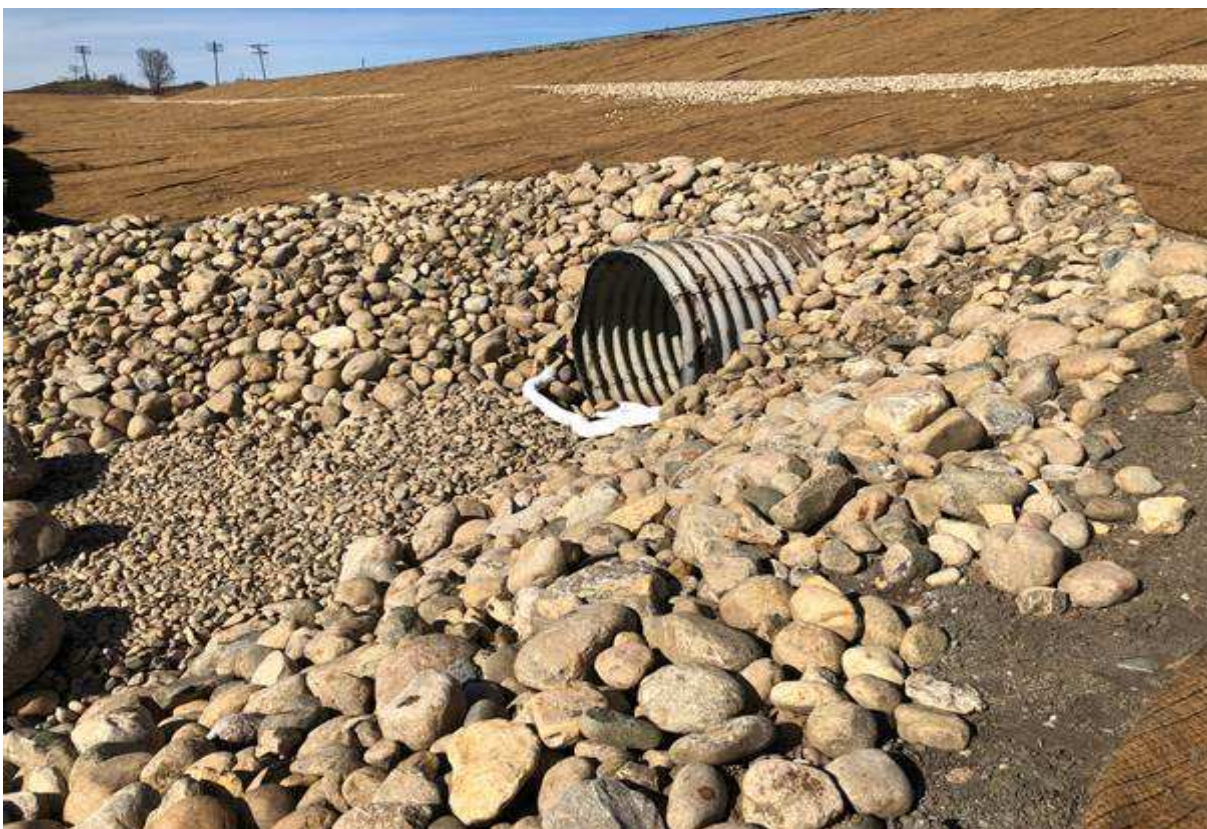
Photo 21: View of south end of east culvert after absorbent boom deployment – no outflow of surface water.

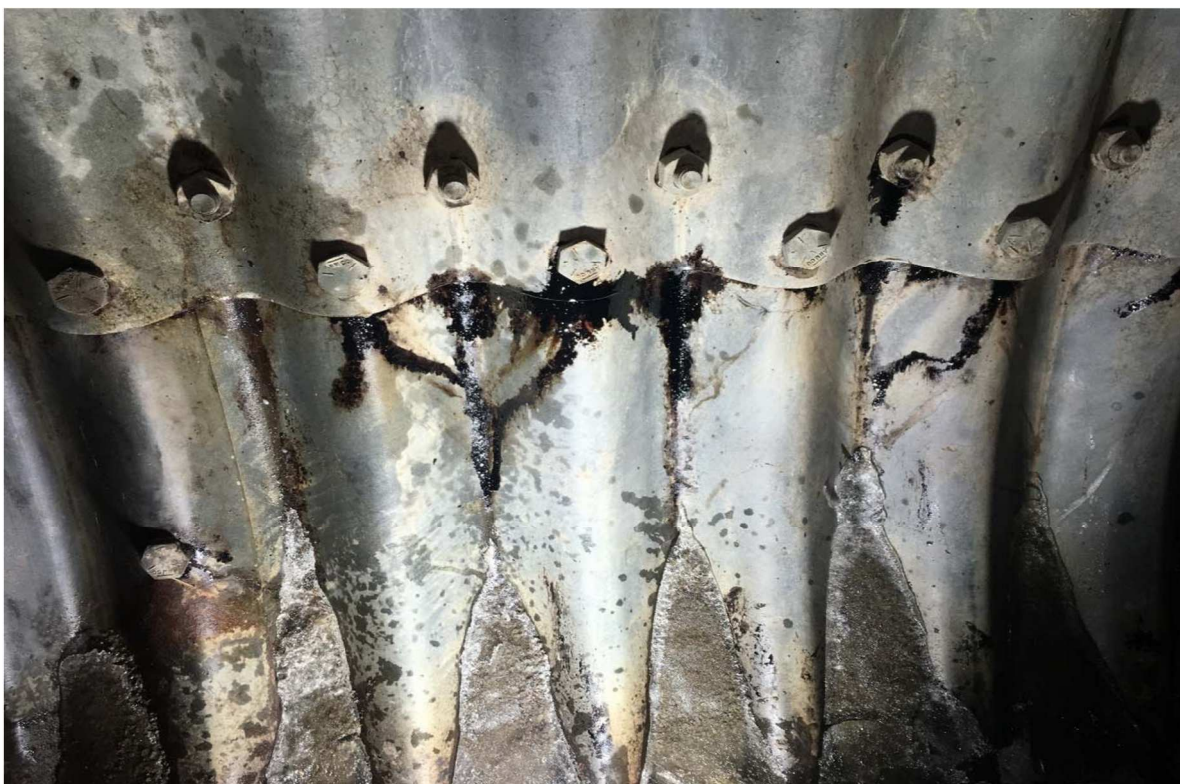
Photo 22 – Seepage in east culvert prior to cleaning as observed on April 14, 2019.

On Sunday, April 14, 2019, Tervita along with GFL attended the Site. Tervita entered east culvert and cleaned the seepage that had adhered to the inside of the east culvert. As required by provincial Worksafe regulations, all personnel reviewed confined space entry procedures, confined space rescue plans and roles/responsibilities required to complete the entry into the culvert. Trace amounts of intermittent hydrocarbon seepage was observed over a length of about 11.6 m at the interior, horizontal joint connections within the east culvert. Standing water was present within the culvert. The hydrocarbon seepage, at the lowest at point of entry, was observed to be approximately 6 inches above any standing water. No product or hydrocarbon sheen was observed in the standing water.

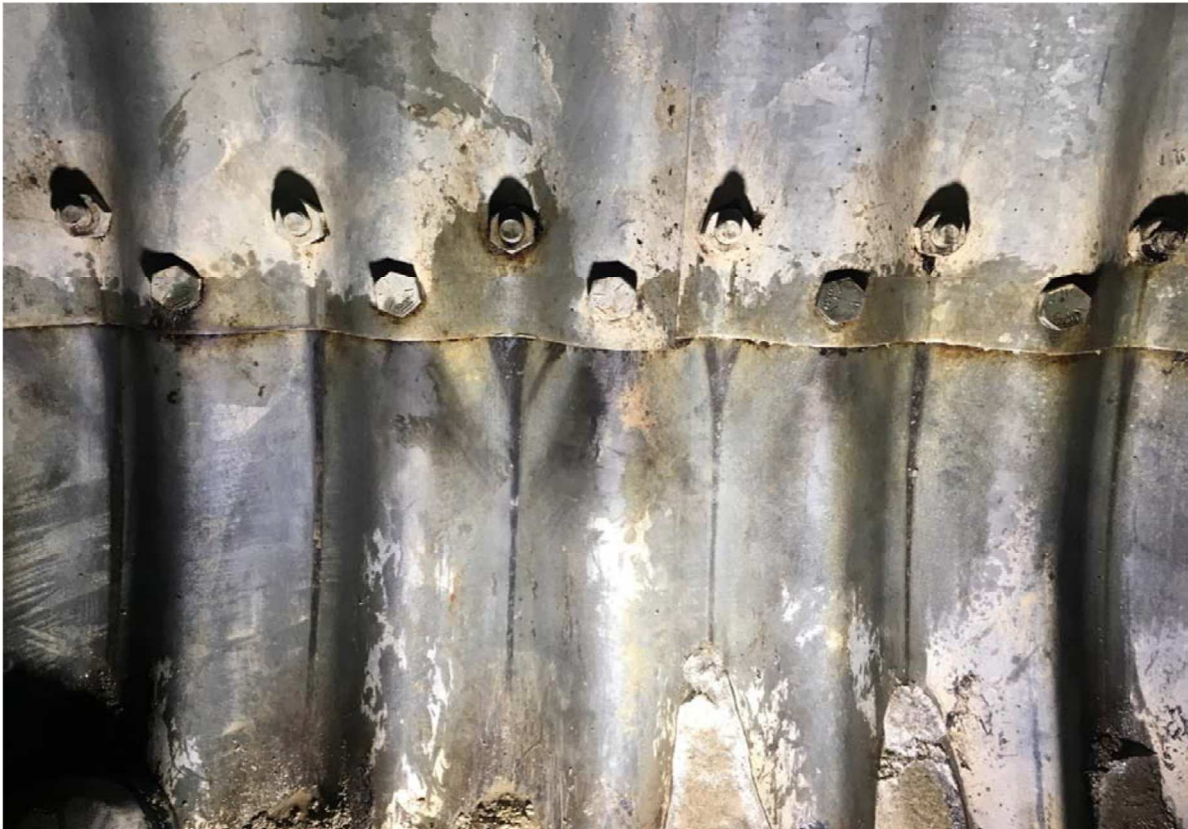
Photo 23 – Seepage in east culvert after cleaning as observed on April 14, 2019.

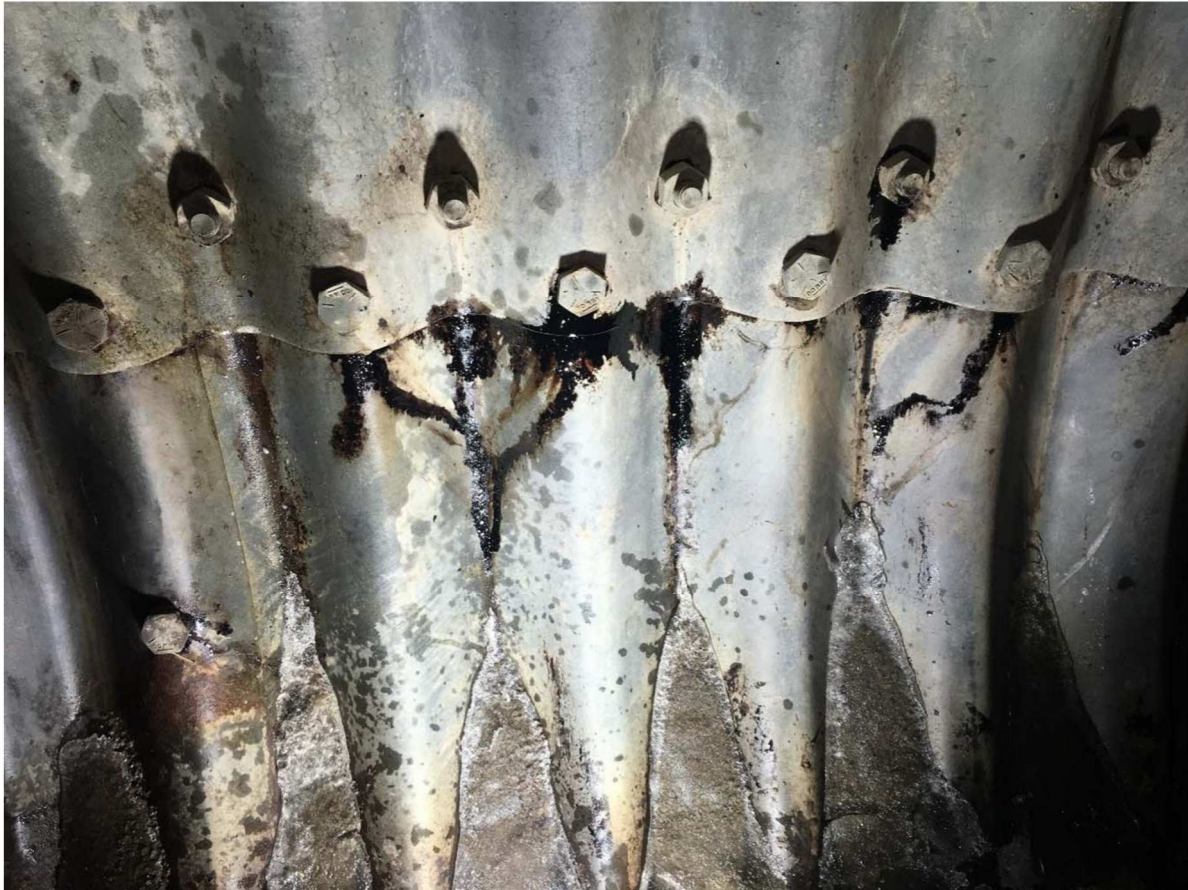
Photo 24 – Seepage in east culvert prior to cleaning as observed on April 14, 2019.

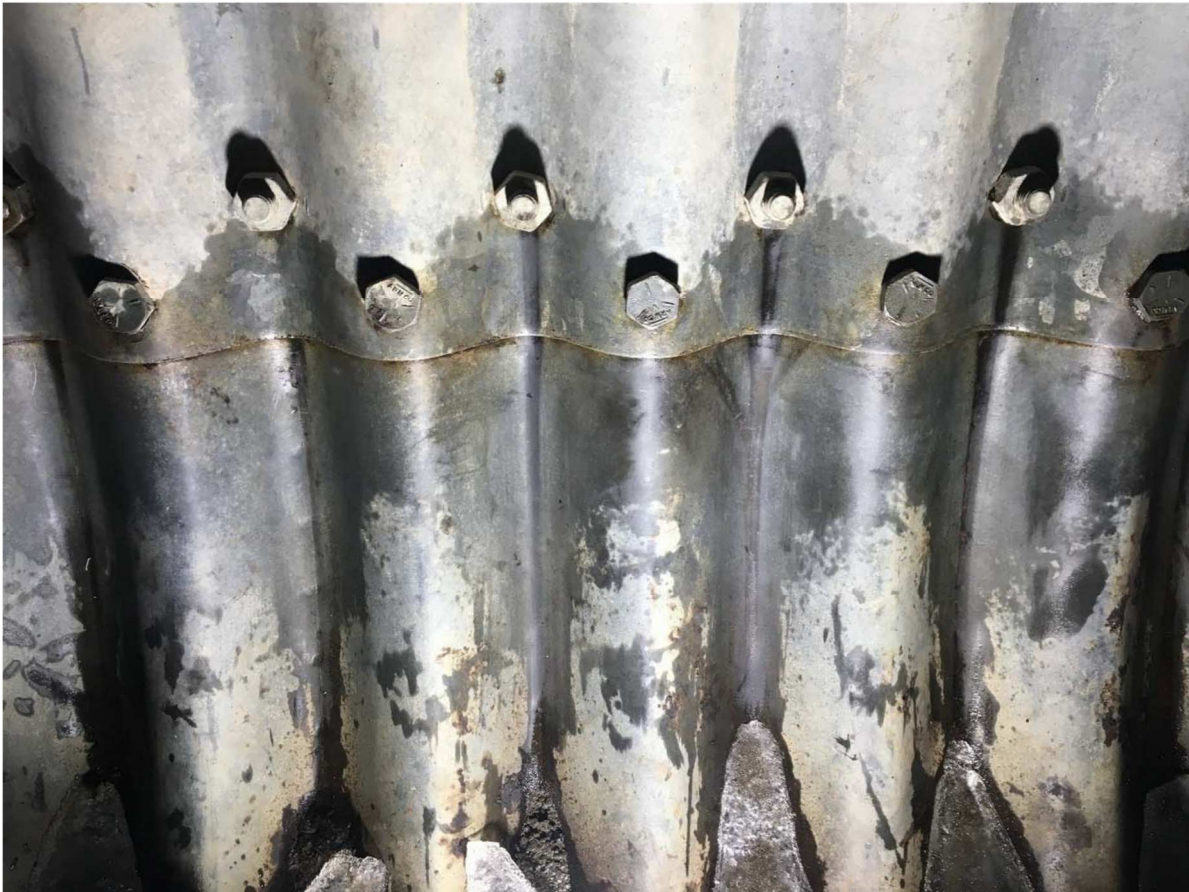
Photo 25 – Seepage in east culvert after cleaning as observed on April 14, 2019.
