Memo

Project No. 10161797

Project: CN MP 197.4, Rivers Subdivision Derailment

Subject: Summary of Intrusive Investigation – May 2019

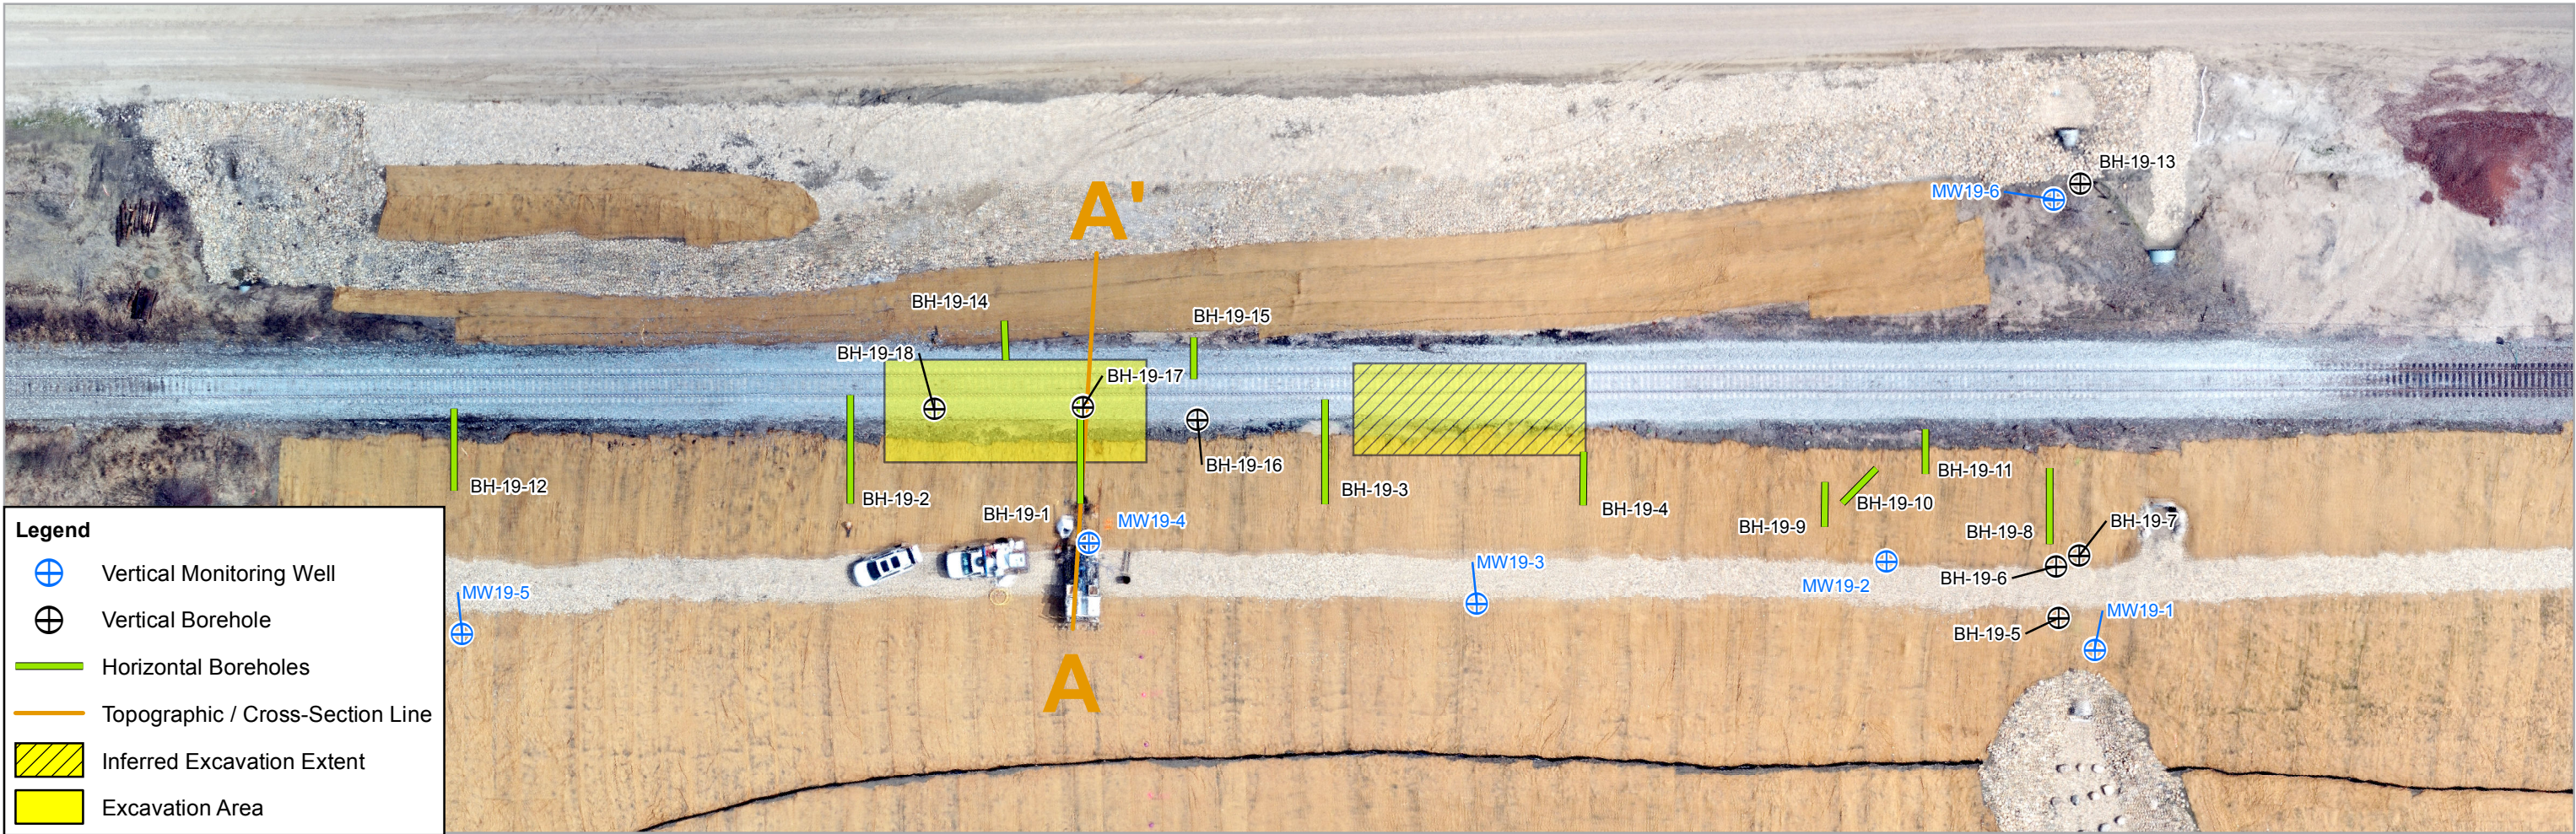
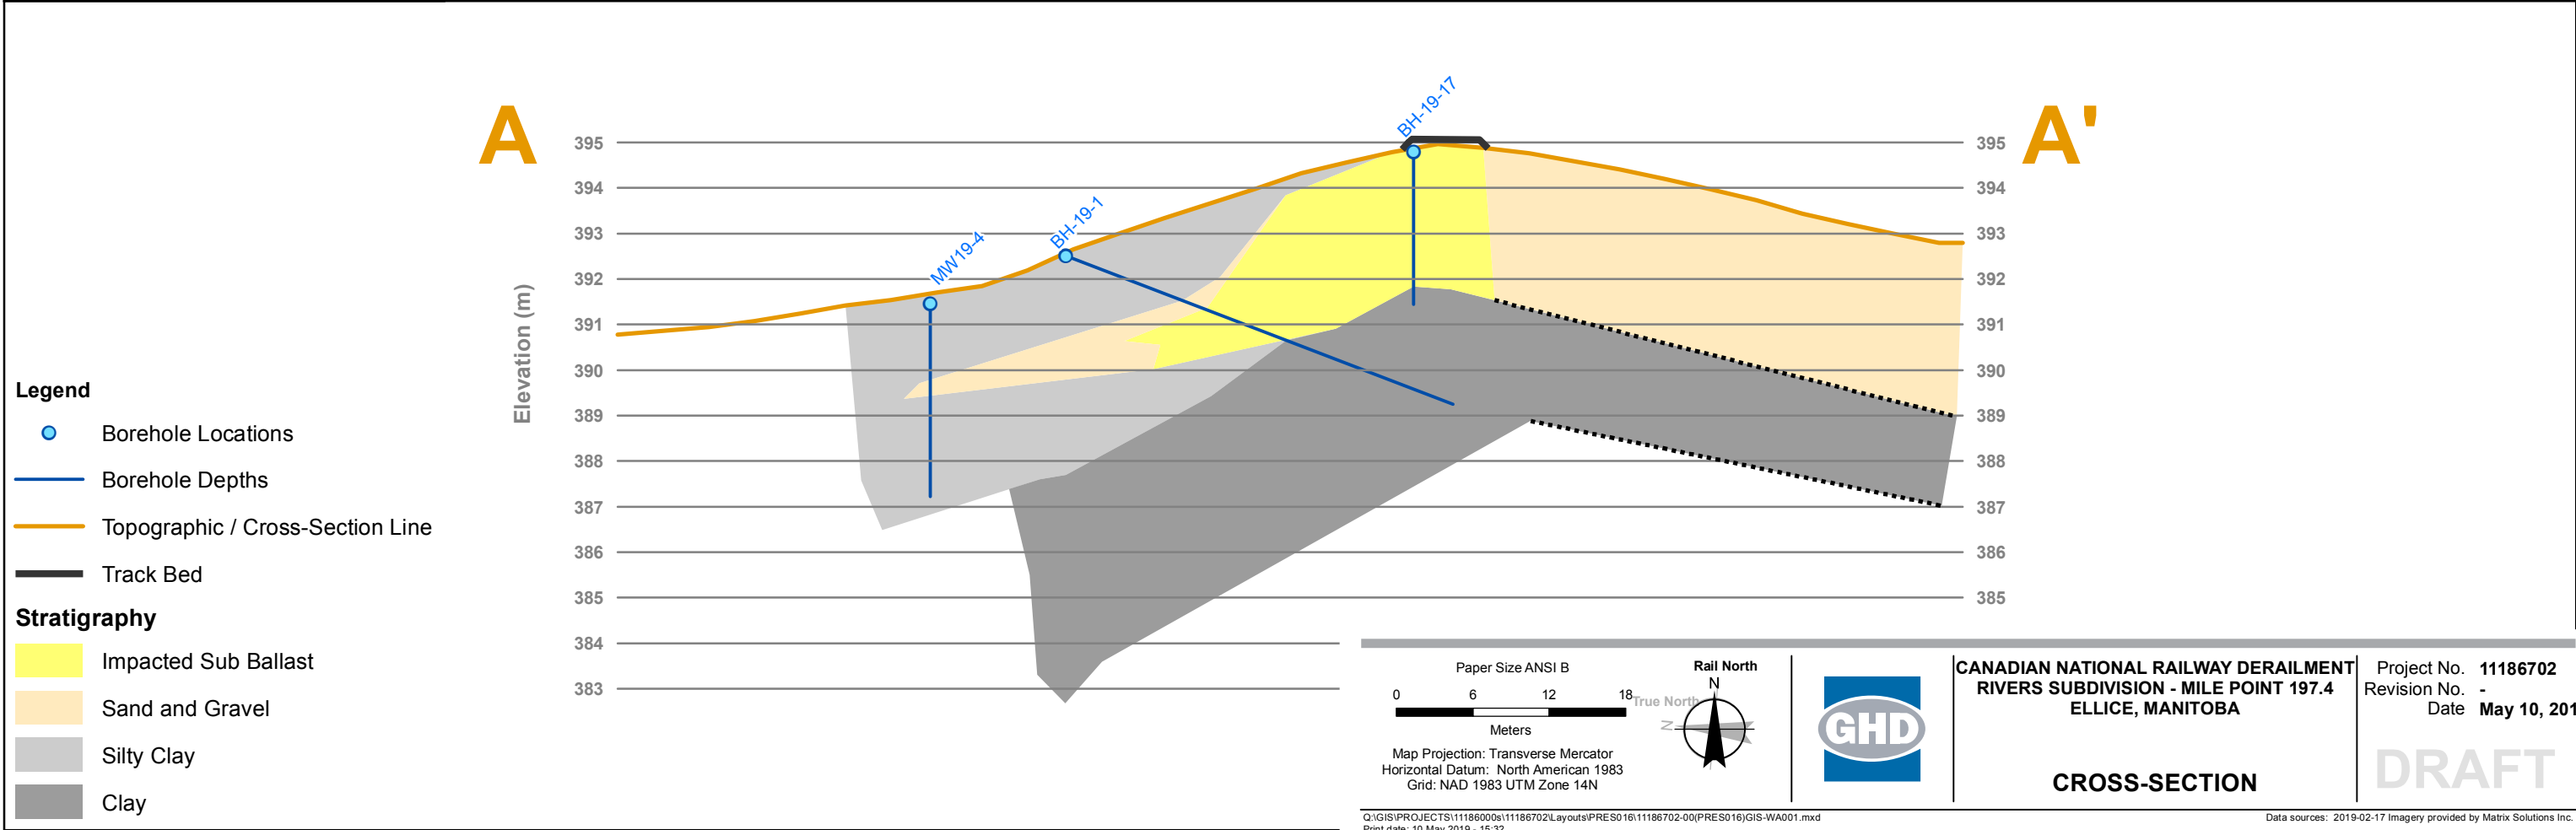
The area of investigation showing the borehole/monitoring well locations along with a cross-section are present in the attached Cross-Section Figure.

- At depth, frozen soils and buried organic soils were noted within several borehole locations;
- Potential soil impacts associated with the derailment in February 2019 were only observed within the coarse-grained materials associated with the sub ballast materials beneath the track bed in 1 directional borehole BH19-1 and 2 vertical boreholes completed from the top of the track bed to delineate BH19-1;

- Clay layers underlying the sub ballast material did not appear to be impacted based on visual assessment and soil headspace readings;
- The clay layer beneath sub ballast material containing CLB appeared to act as a very effective confining layer with no downward migration of CLB observed within the clay layer;

An area of residual CLB was identified in the vicinity of BH19-1. The CLB appeared to be confined to the sub ballast material within the track bed with the clay layer below acting as a confining layer. It is anticipated that some additional CLB may remain in the sub ballast material within the track bed beyond this area; however, rail traffic limited the number of vertical boreholes that could be completed from the top of the track bed.

While laboratory analytical results are still pending, an excavation area has been identified for the track bed based on Site imagery collected of the derailment Site from the day after the derailment

(February 17) to demobilization of the initial response, the GPR survey and the soil stratigraphy observed during the intrusive investigation. The volume of potentially impacted soils to excavate, based on the area identified is approximately 1,178 m³.
