2025 AIS Early Detection and Rapid Response Summary

MARCH 2026

AIS Early Detection and Rapid Response Program Structure

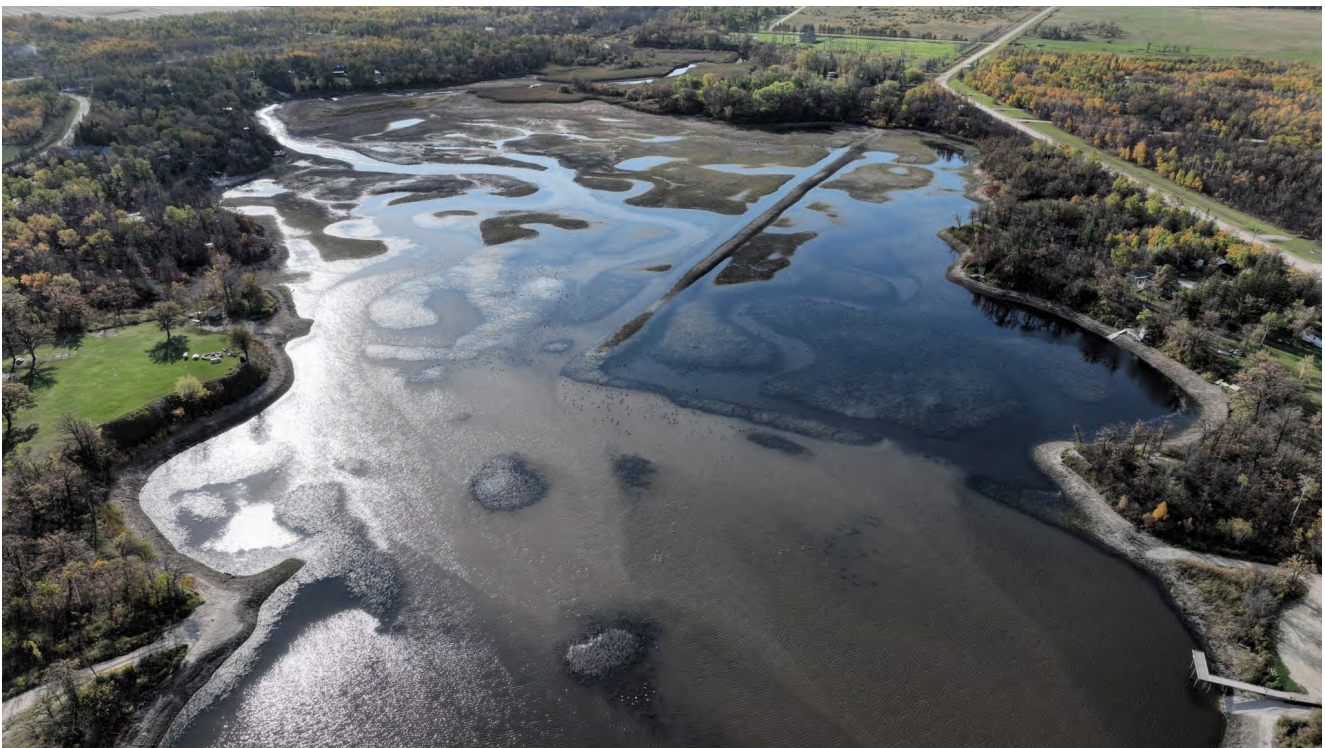
Plate 1: South portion of St Malo Reservoir at maximum drawdown.

To assess the feasibility of eradicating Zebra Mussels within the reservoir, Manitoba conducted a partial drawdown of the St Malo reservoir to assess reservoir bank stability, as well as to understand how biota in this reservoir respond to receding water levels. Beginning in September, water levels were lowered approximately 2.1 metres over a 12-day period (an approximate removal of 45 per cent of the reservoir's water volume). The south basin of the reservoir near the Rat River inflow had the largest de-watering effect (e.g., **Plate 1**). Banks throughout the reservoir remained stable, although some localized slumping was observed.

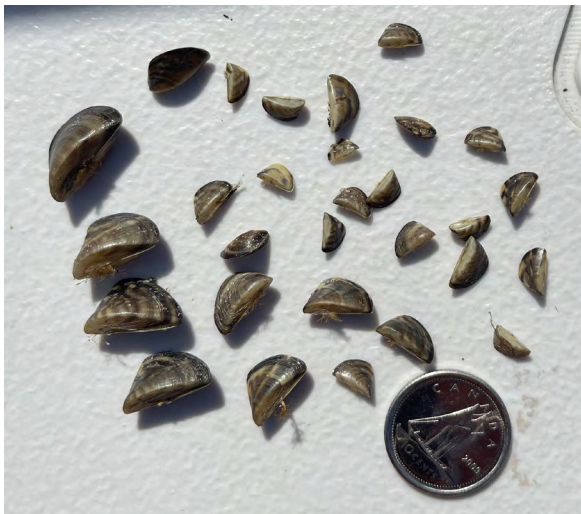
Plate 2: Size distribution of suspect ≤ 1 year old zebra mussels found on a single watercraft moored in St Malo Reservoir relative to a Canadian dime.

During this project, adult Zebra Mussels were found to be nearly continuously distributed along the shoreline (**Figure 1**). Zebra Mussels were primarily found on boats, docks and other infrastructure, but also on natural substrates such as rocks and native vegetation. Zebra Mussels spanned a wide range of size classes (**Plate 2**), with largest individuals being found on natural substrates (e.g., **Plate 3**).

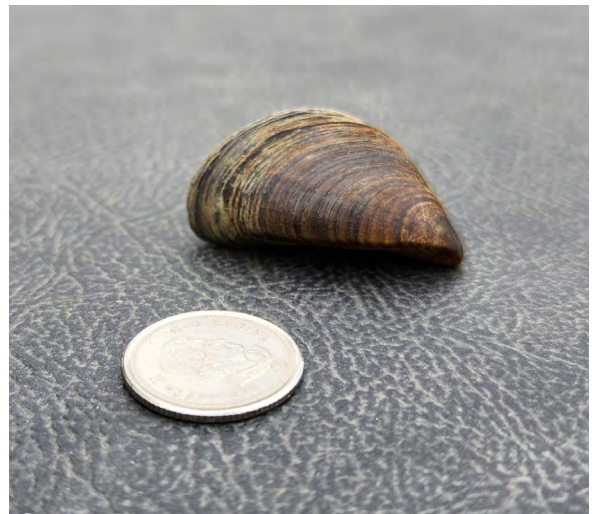
Plate 3: Large Zebra Mussel (>1 year old) recovered from natural substrate in St Malo Reservoir.

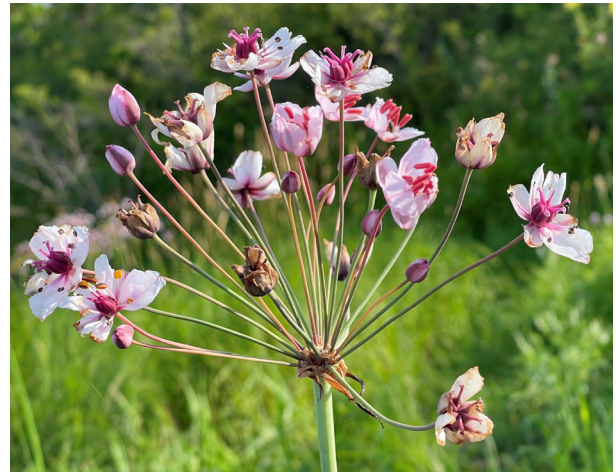
Plate 4: Flower umbel characteristic of Flowering Rush.

Flowering rush (*Butomus imbellatus*) is a Eurasian invasive plant species intentionally introduced to North America as part of the ornamental plant trade. It was first identified in North America in the late 1890s along the St. Lawrence River near Montreal and has since spread rapidly across many Canadian provinces and northern United States by natural dispersal, anthropogenic vectors and intentional introductions. Flowering Rush is most easily identified by its light pink flowers that occur in umbels that resemble an upside-down umbrella (**Plate 4**).

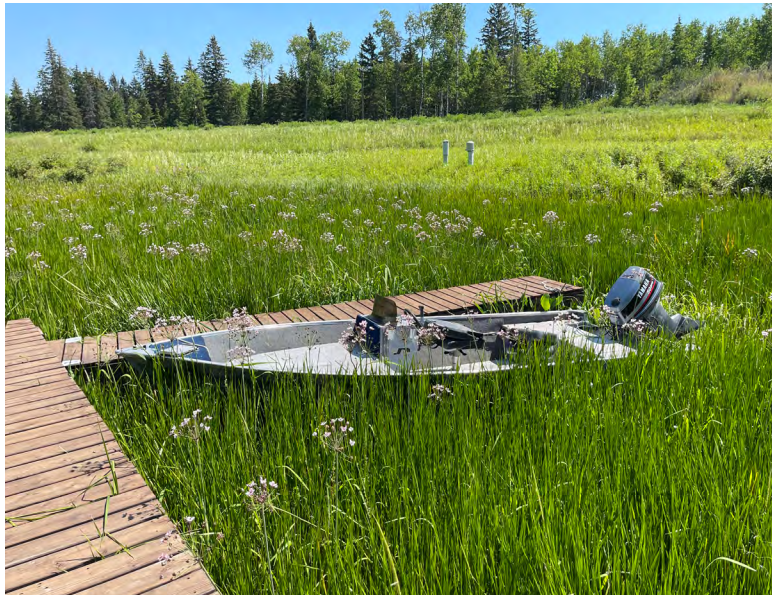
Plate 5: Flowering Rush surrounding a watercraft in Poplar Bay, Lake Lac du Bonnet, Manitoba.

Flowering rush can cause several negative impacts, including forming dense stands that can displace native vegetation and restrict waterbody access, reduce biodiversity through alterations to fish and wildlife habitat, impact water supply if established in irrigation canals, reservoirs or stormwater ponds and restrict recreational activities such as swimming, boating and fishing (**Plate 5**).

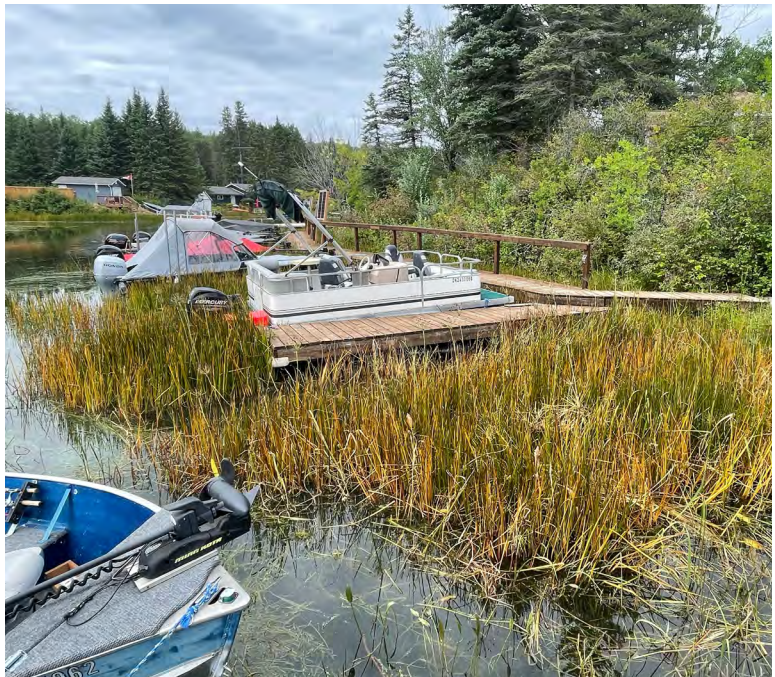
Plate 6: Flowering Rush die-back observed three-weeks post treatment in Poplar Bay.

In 2025, the Manitoba AIS Unit completed three spray programs: (1) Poplar Bay in Lake Lac du Bonnet, (2) Auglen (Kulikowski) Channel of the Lee River and (3) St Malo Reservoir. At all three of these locations, Flowering Rush density was high, with near continuous occurrences along the shorelines that interfered with watercraft movement and/or posed a high-risk of fragmentation and spread (e.g., **Plate 5**). Initial treatments proved to be effective, with widespread die-back of Flowering Rush observed approximately 3-weeks post treatment (**Plate 6**). These areas will be monitored in 2026 and will under-go further treatment as required.

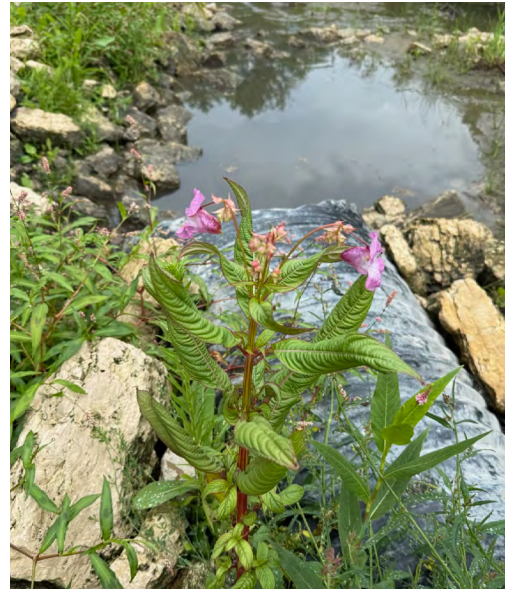
Plate 7: Himalayan Balsam flowering along Bunn's Creek, Winnipeg, Manitoba.

Himalayan Balsam (*Impatiens glandulifera*) is an invasive plant introduced into North America as part of the ornamental plant trade. This plant creates dense stands, capable of growing up to three metres tall, preventing native plant growth and thereby reducing local biodiversity. The loss of local perennial plants along shorelines caused by Himalayan Balsam's aggressive growth, coupled with its shallow roots, can lead to soil erosion over time. One Himalayan Balsam plant can produce up to 800 seeds. Once matured and dried, seed heads "explode," shooting up to five meters away, which allows the plant to spread rapidly. Himalayan Balsam is most easily identified by its pink flowers that have a hooded shape that looks like a policeman's helmet (e.g., **Plate 7**).

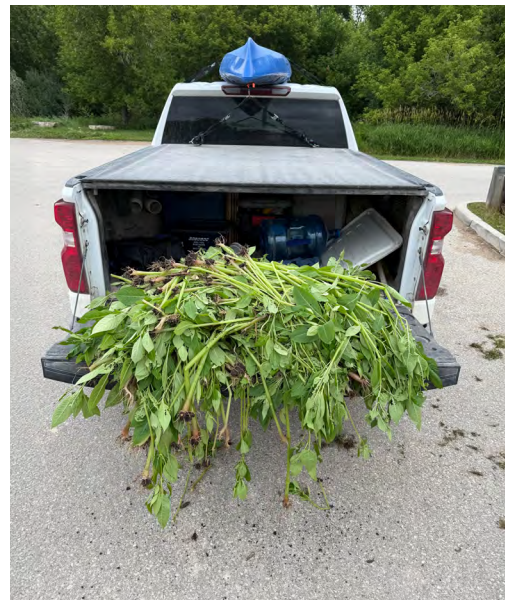
Plate 8: Himalayan Balsam removed from Trappist Monastery Provincial Heritage Park.

The infestation within Trappist Monastery Provincial Heritage Park was dense, with approximately three stands 10 by 10 metres with hundreds of individuals, approximately 50 metres from the La Salle River (e.g., **Plate 8**). Hand-pulls were completed bi-weekly, on four occasions, until no additional plants were found.
