2011 Flood: Technical Review of Lake Manitoba, Lake St. Martin and Assiniboine River Water Levels

October 2013

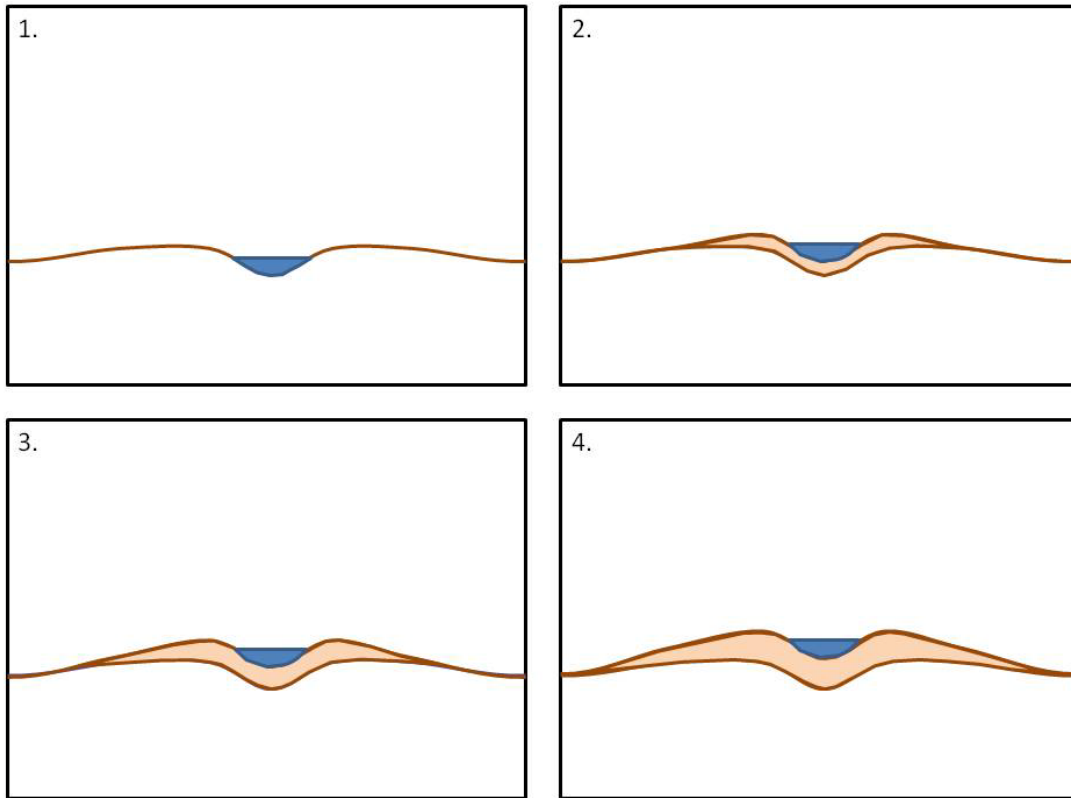
Figure 4: Formation of an alluvial ridge. Note that deposition builds up natural levees on each side of the stream as well as in the bed of the stream.

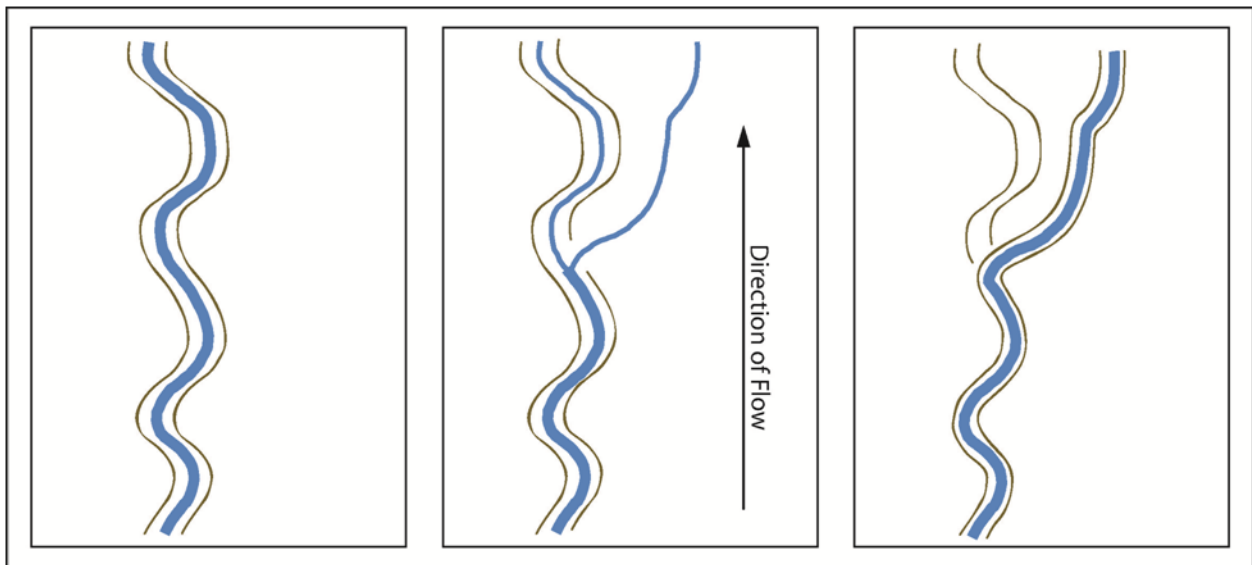
Figure 5: Sequence of events leading to avulsion on the alluvial fan. The top of the natural levees on the alluvial ridge are shown as the brown line next to the river.

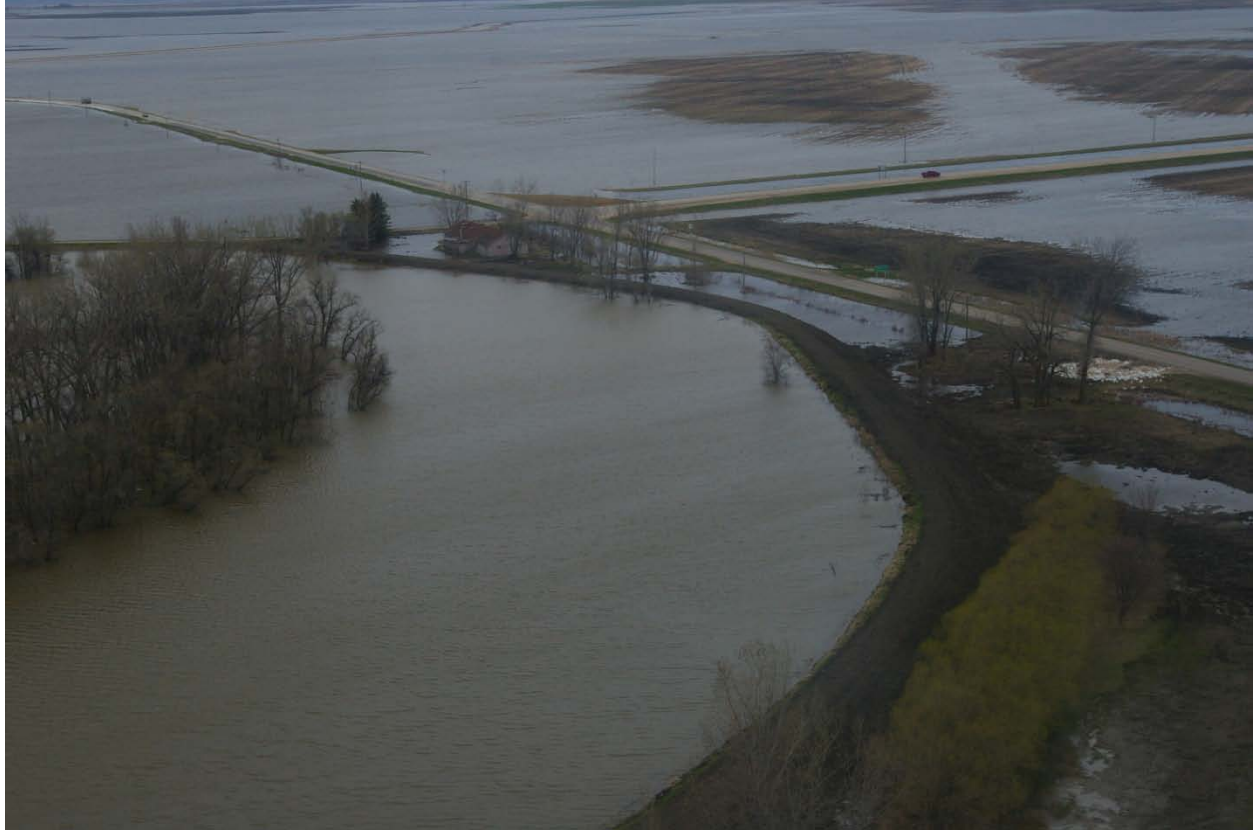
Figure 28: Photograph of the Assiniboine River and dikes in the vicinity of Baie St. Paul, taken on May 15, 2011. Note that there is freeboard remaining on the dikes (they are not in danger of being overtopped).

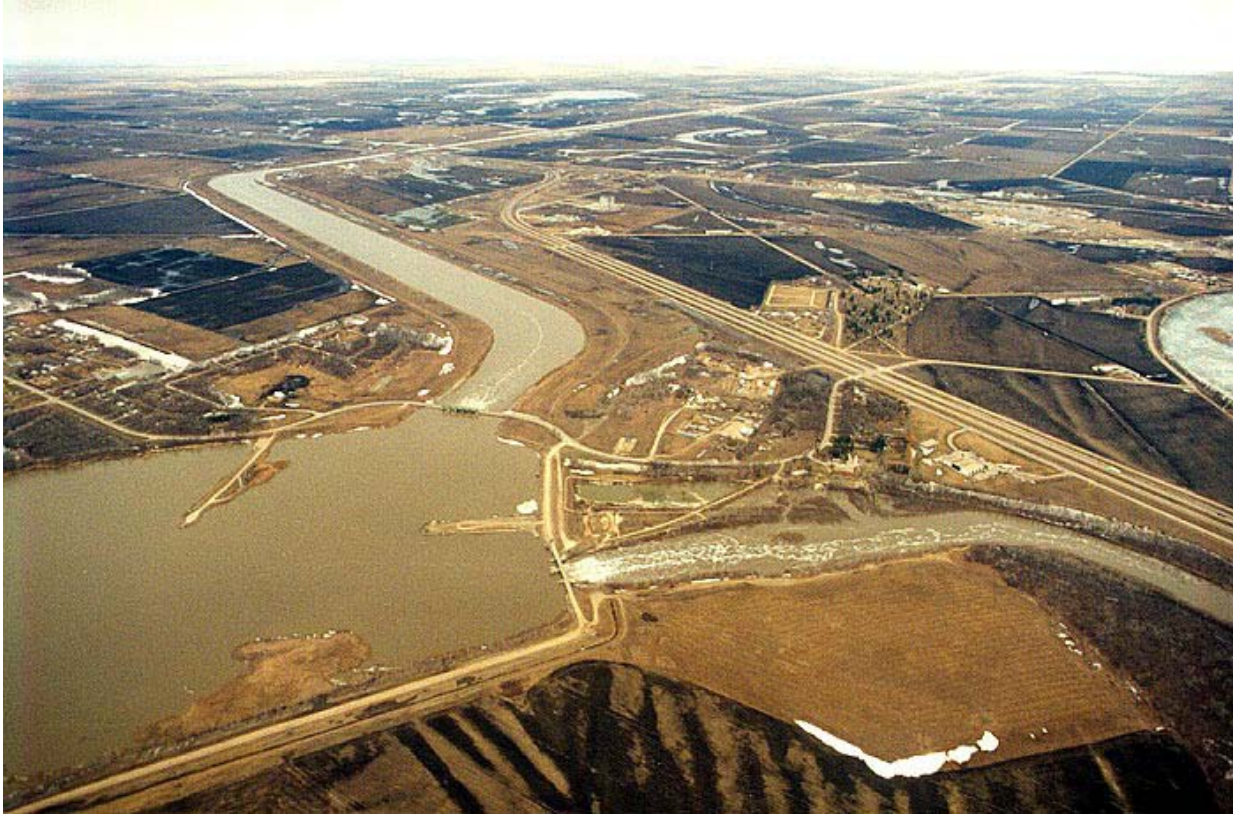
Figure 29: An aerial photograph of the Portage Diversion during a flood event; the year is unknown. The Portage Reservoir is visible on the left edge of the photo, the diversion channel continues northward into the background of the photo, and the Assiniboine River flows off the right hand edge of the photo. Of note, a portion of the Blind (or Fort la Reine) paleochannel is visible downstream of the control structure on the river, running north from the highway into the background.

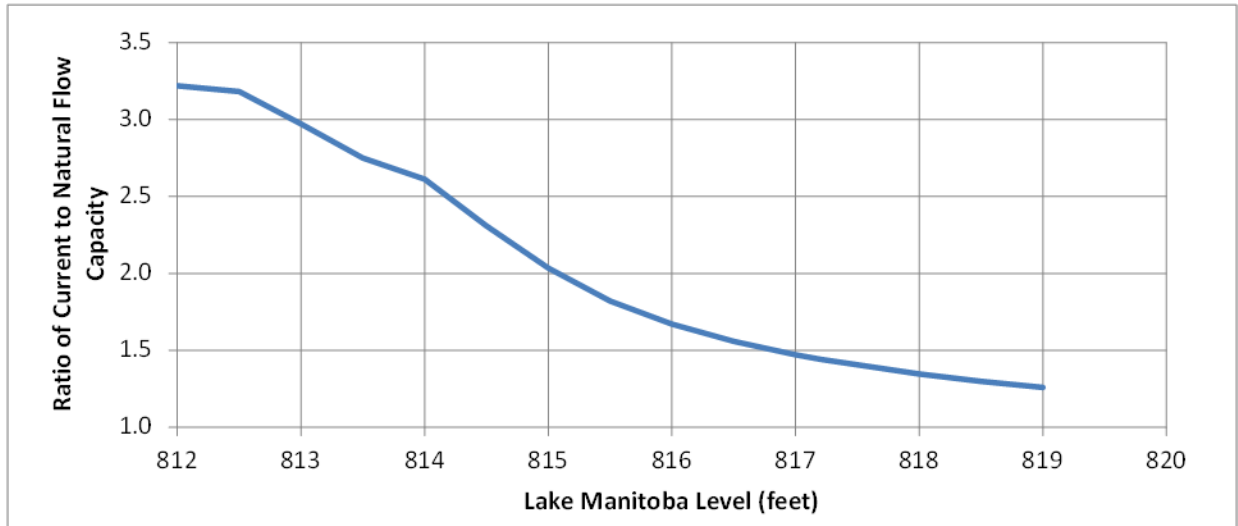
Figure 32: Ratio of the enhanced outflow capacity through the Fairford River water control structure compared to unregulated outflow capacity at different lake levels.

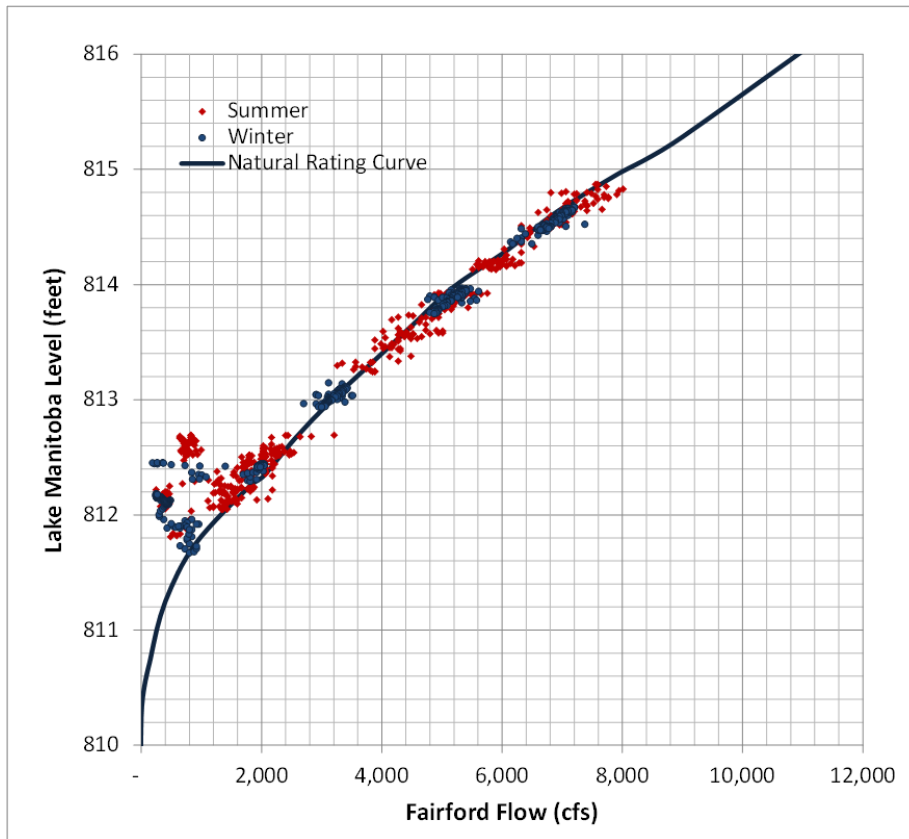
Figure 39: Lake Manitoba natural outflow rating curve.

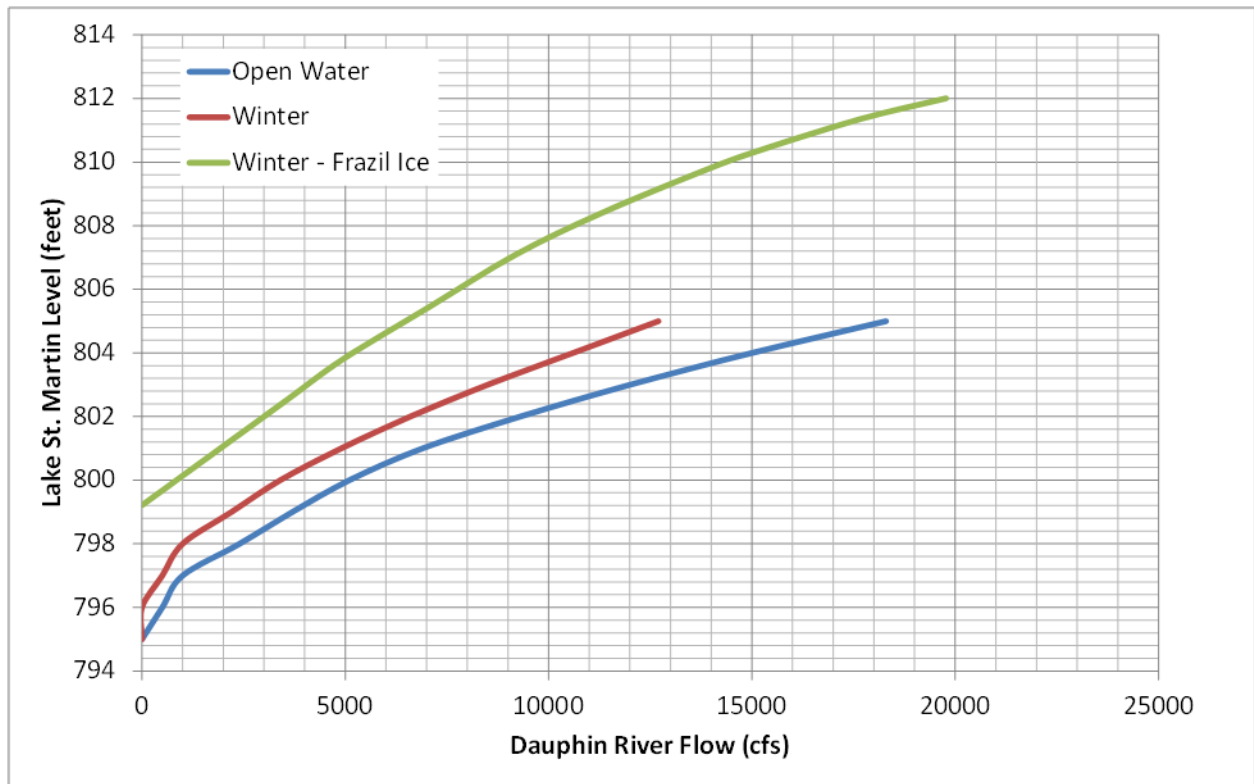
Figure 41: Lake St. Martin outflow rating curves.

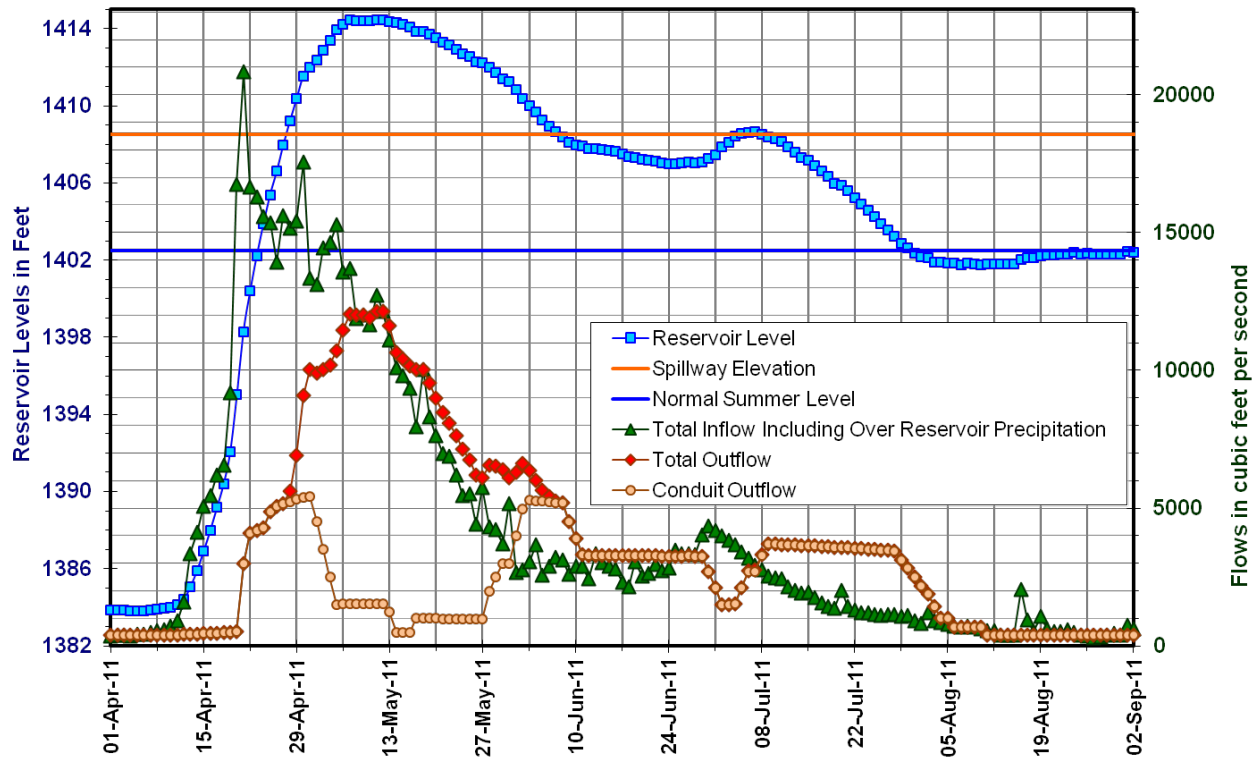
Figure 44: 2011 Shellmouth Reservoir water levels, inflows and outflows.

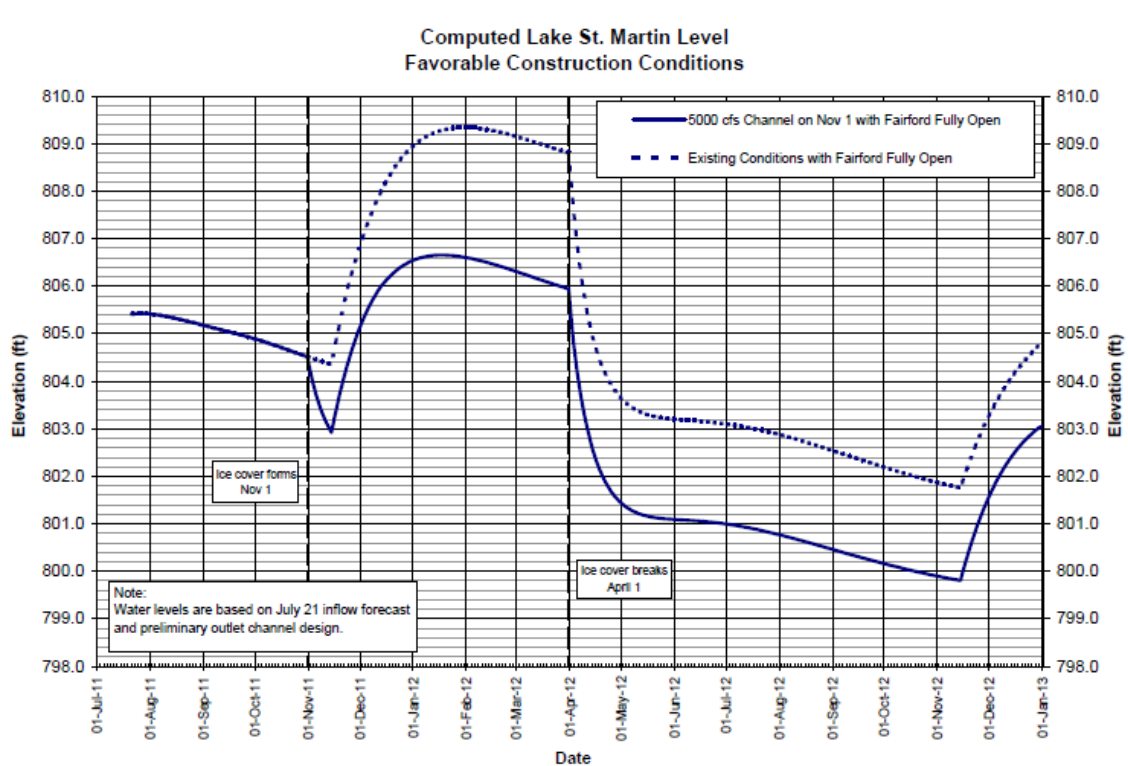
Figure 56: Lake St. Martin Levels with and without an emergency outlet channel through the winter of 2012, as modelled in the summer of 2011 (KGS Group and AECOM, 2011).

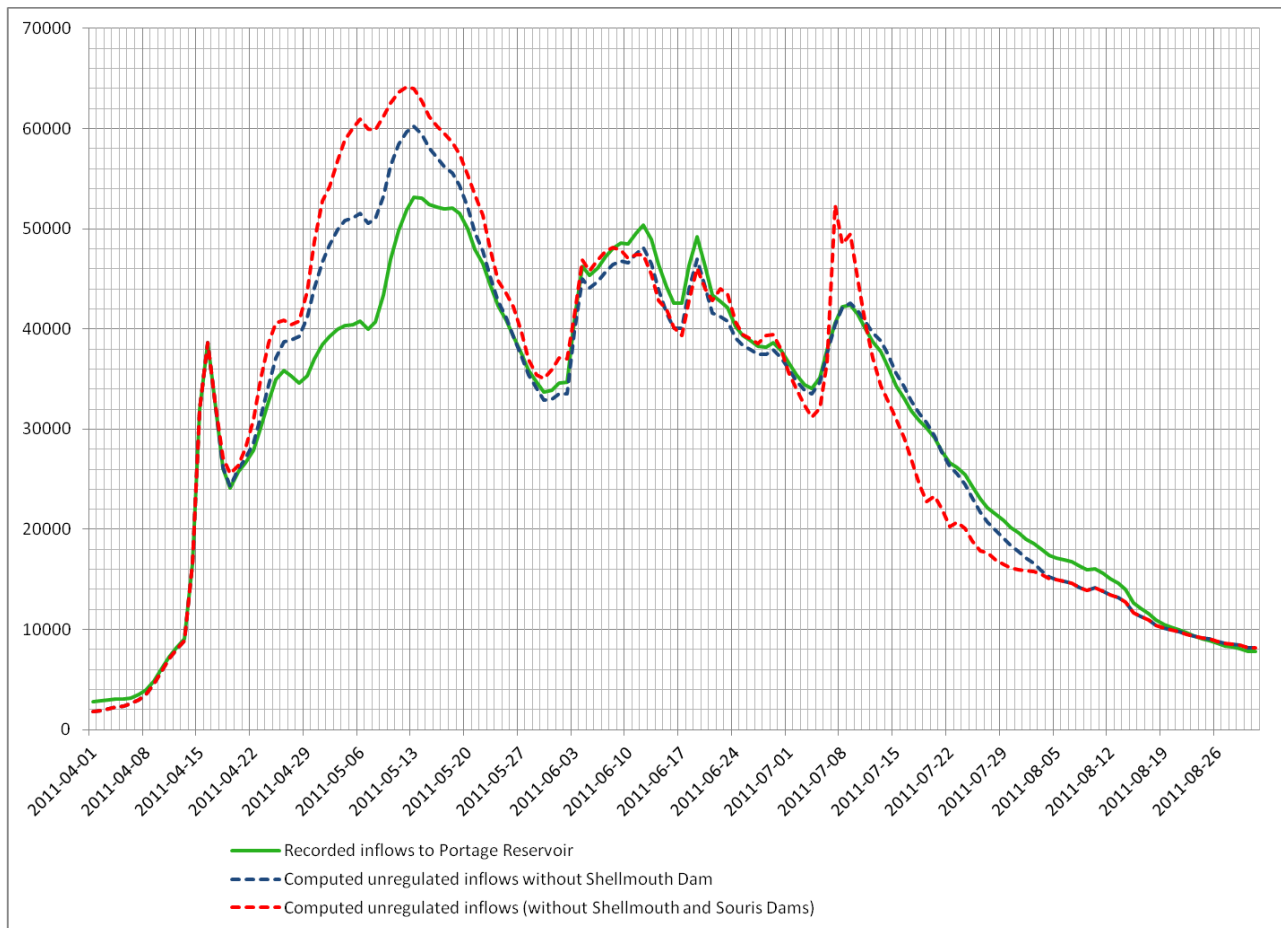
Figure 58: Recorded and unregulated flows on the Assiniboine River at the Portage Reservoir in 2011.

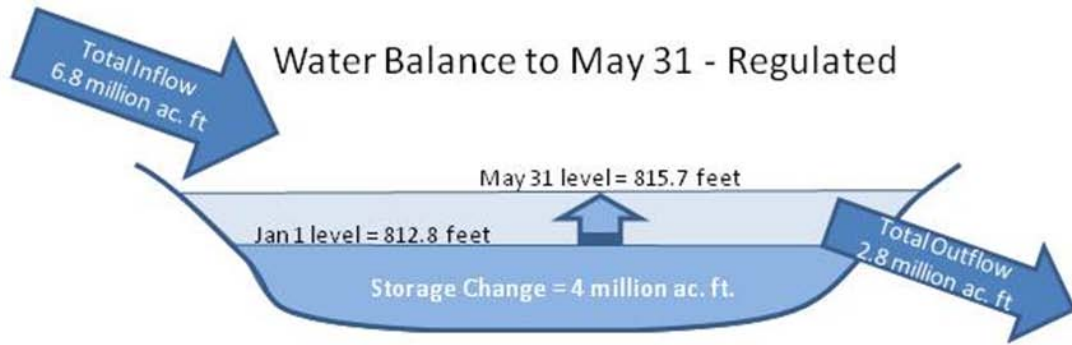
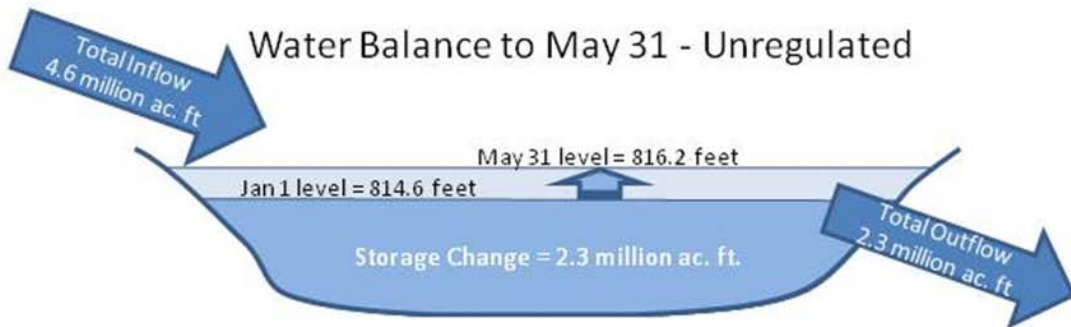
Figure 66: Lake Manitoba inflows and outflows, January 1 to May 31, 2011.

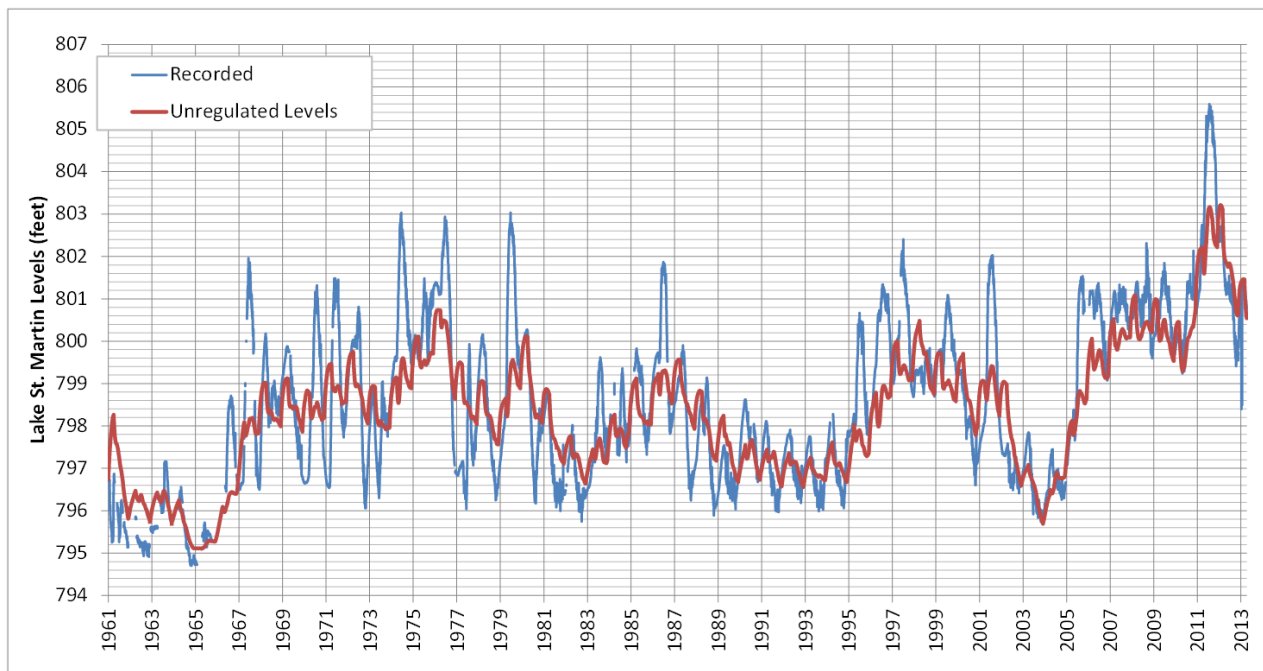
Figure 72: Recorded and unregulated water levels on Lake St. Martin from the start of regulation (1961) to 2013.
