CN Mile Point 197.4, Rivers Subdivision

Project Update

November 7, 2019

## **SUMMARY: CN MP 197.4, RIVERS SUBDIVISION - ENVIRONMENTAL SITE ASSESSMENT AND FISH SALVAGE**

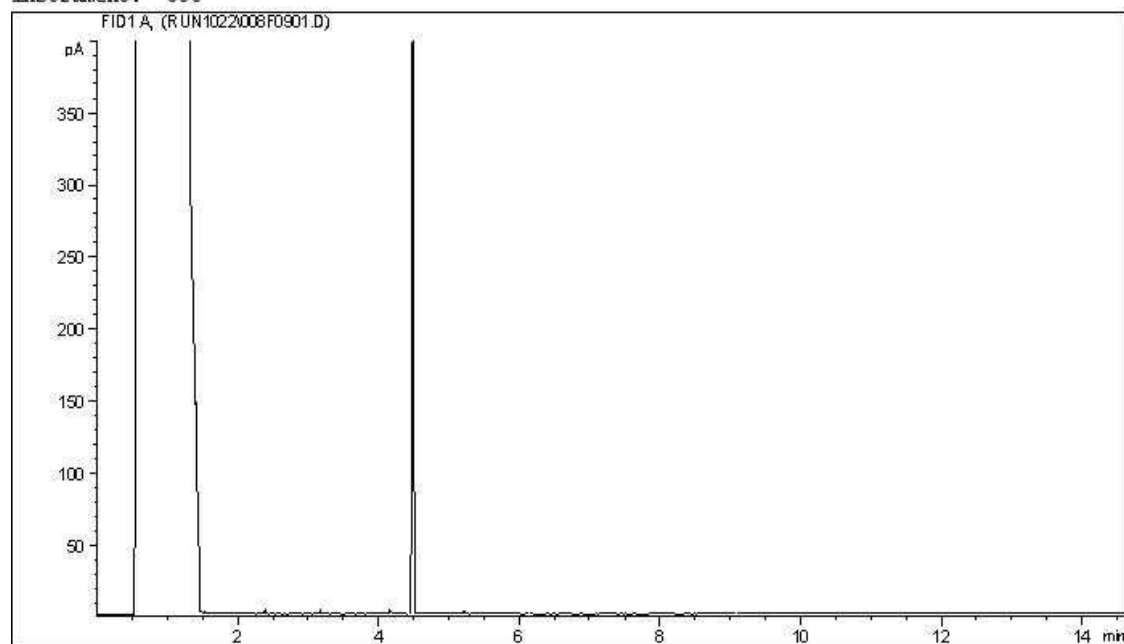
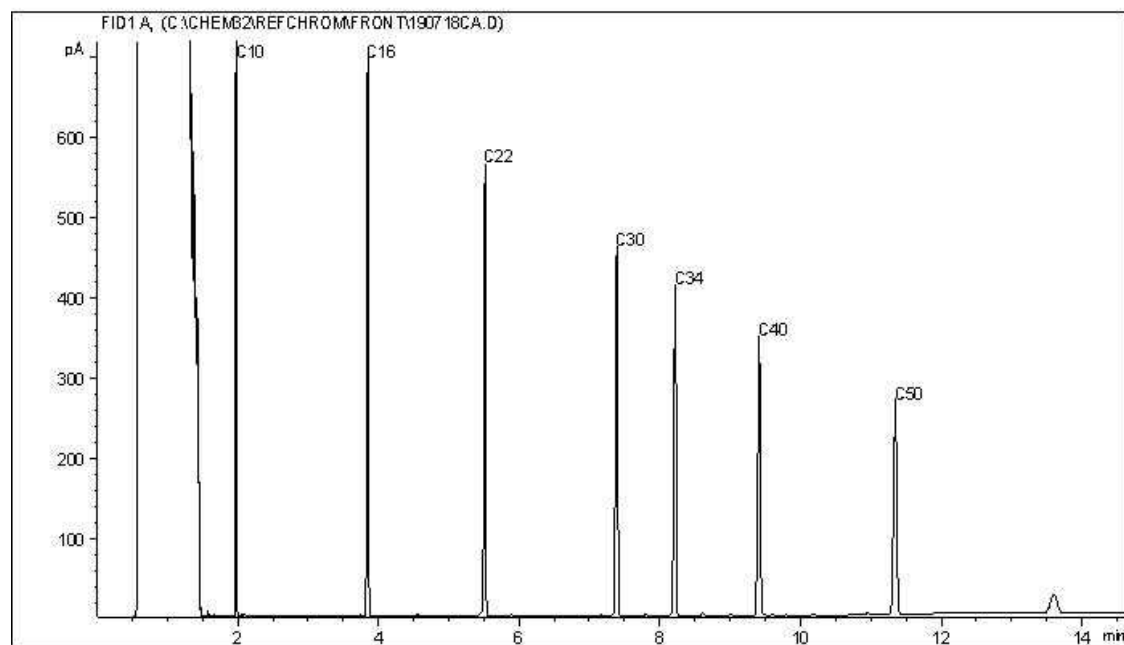
# CCME Hydrocarbons (F2-F4 in water) Chromatogram

Instrument: GC6

## TYPICAL PRODUCT CARBON NUMBER RANGES

Gasoline:	C4 - C12	Diesel:	C8 - C22
Varsol:	C8 - C12	Lubricating Oils:	C20 - C40
Kerosene:	C7 - C16	Crude Oils:	C3 - C60+

The results for all samples analyzed on October 18 and 21, 2019 were below the laboratory detection limits. As no hydrocarbons were detected through laboratory analysis of samples collected directly from the observed sheens on-Site. The sheens observed on October 18, 2019 were considered naturally occurring and unrelated to the CLB release.

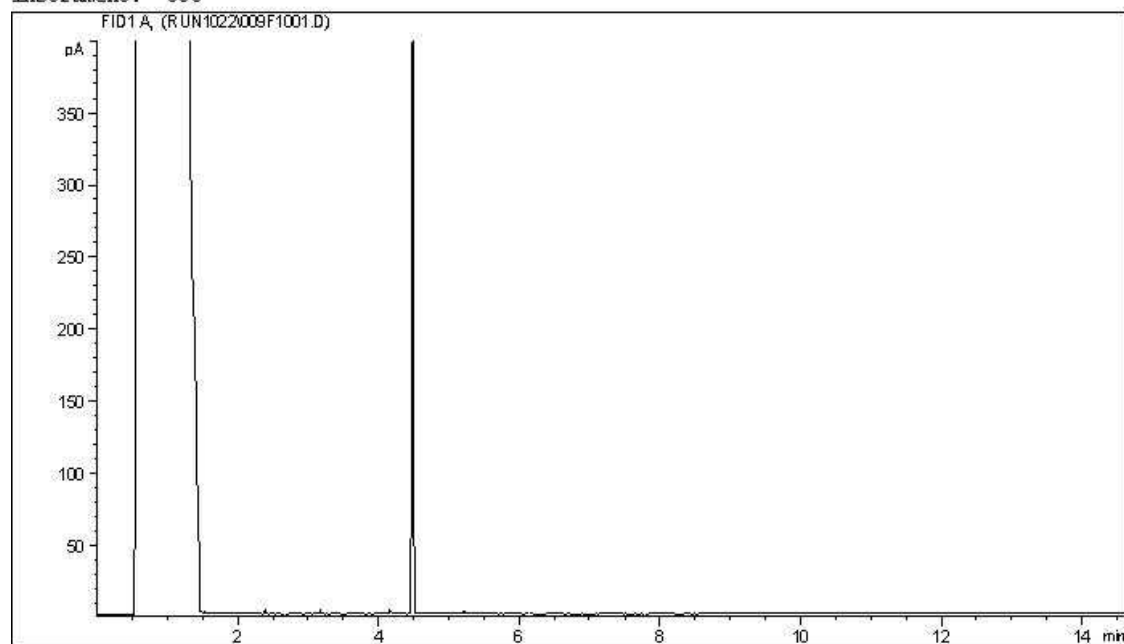
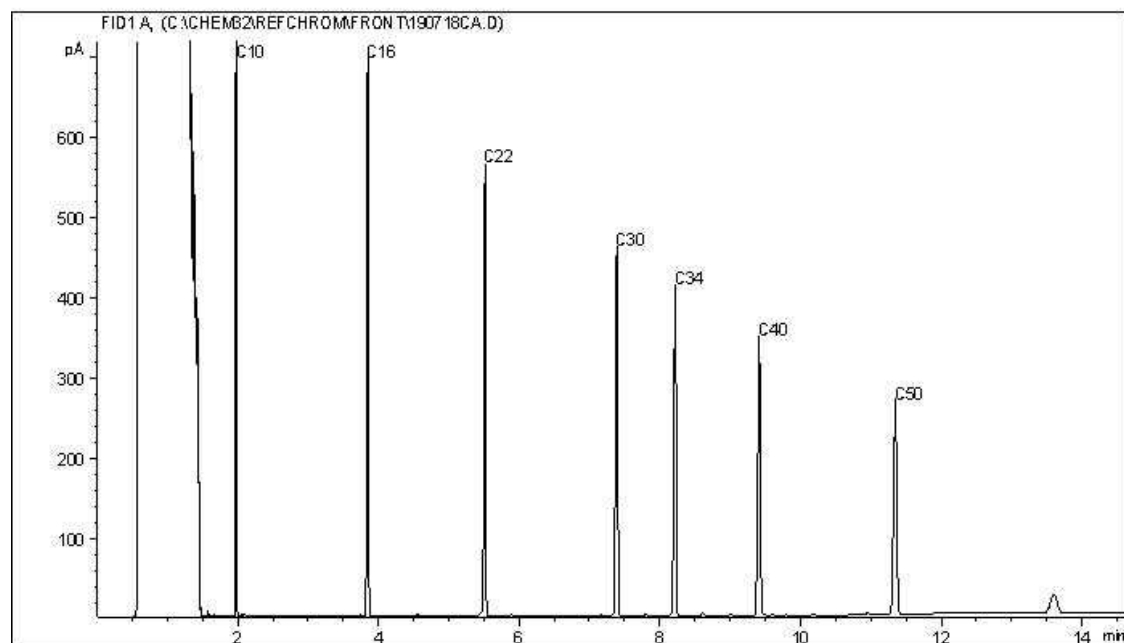
# CCME Hydrocarbons (F2-F4 in water) Chromatogram

Instrument: GC6

## TYPICAL PRODUCT CARBON NUMBER RANGES

Gasoline:	C4 - C12	Diesel:	C8 - C22
Varsol:	C8 - C12	Lubricating Oils:	C20 - C40
Kerosene:	C7 - C16	Crude Oils:	C3 - C60+

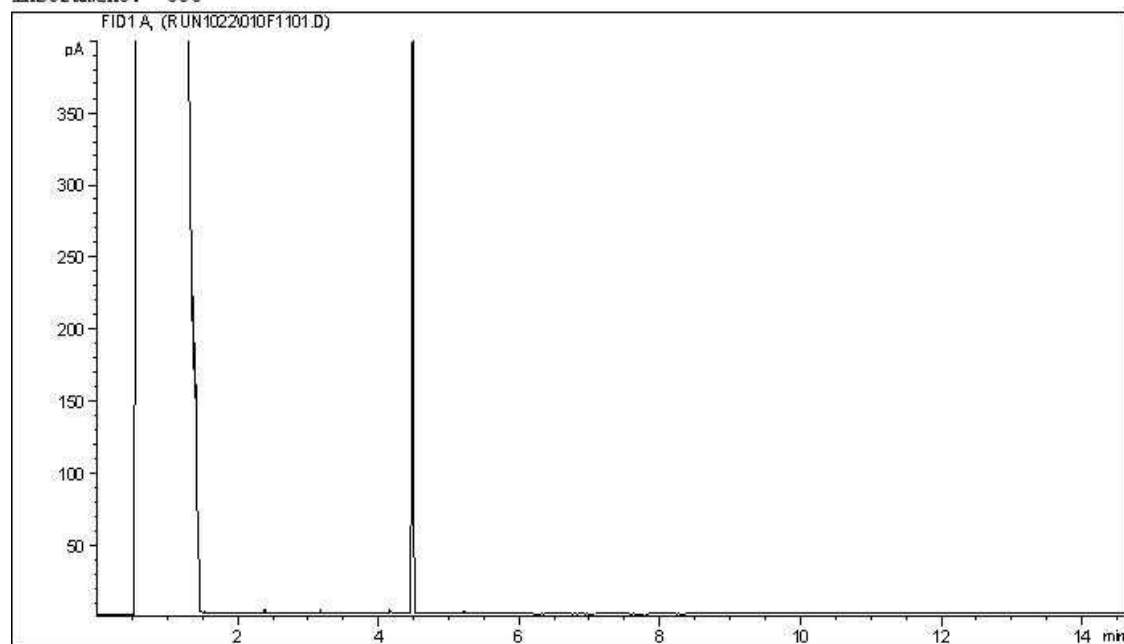
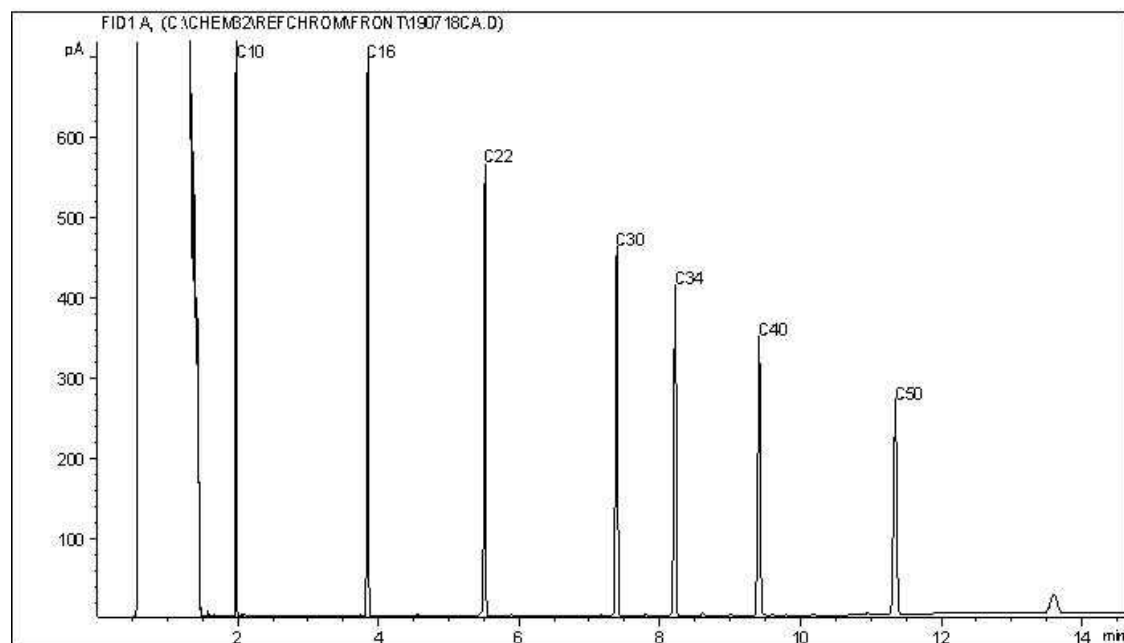
# CCME Hydrocarbons (F2-F4 in water) Chromatogram

Instrument: GC6

## TYPICAL PRODUCT CARBON NUMBER RANGES

Gasoline:	C4 - C12	Diesel:	C8 - C22
Varsol:	C8 - C12	Lubricating Oils:	C20 - C40
Kerosene:	C7 - C16	Crude Oils:	C3 - C60+

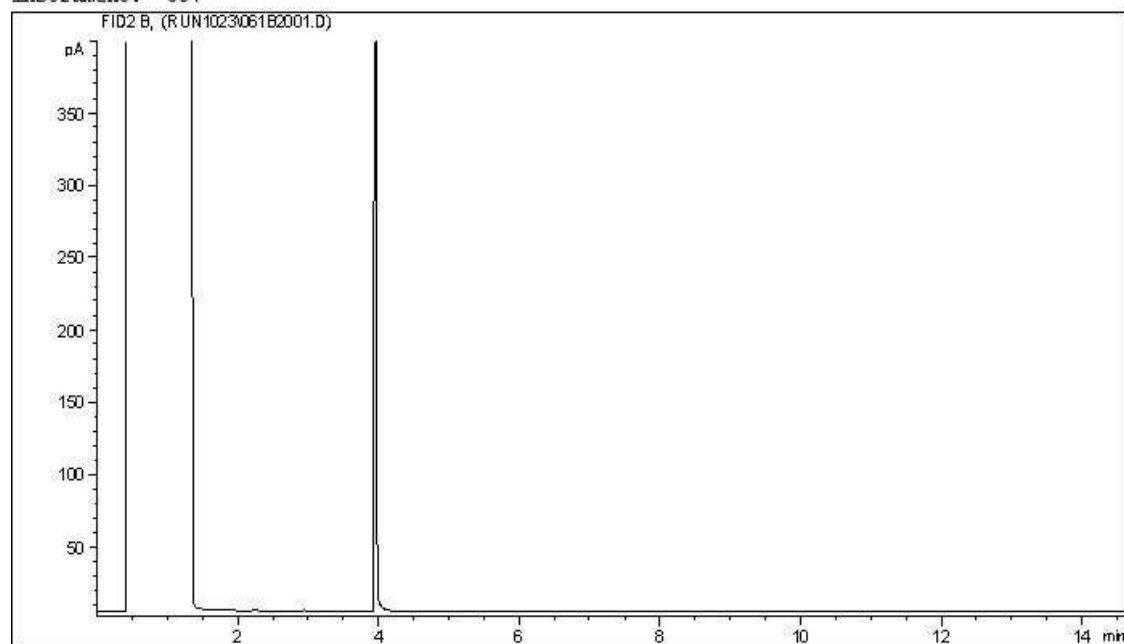
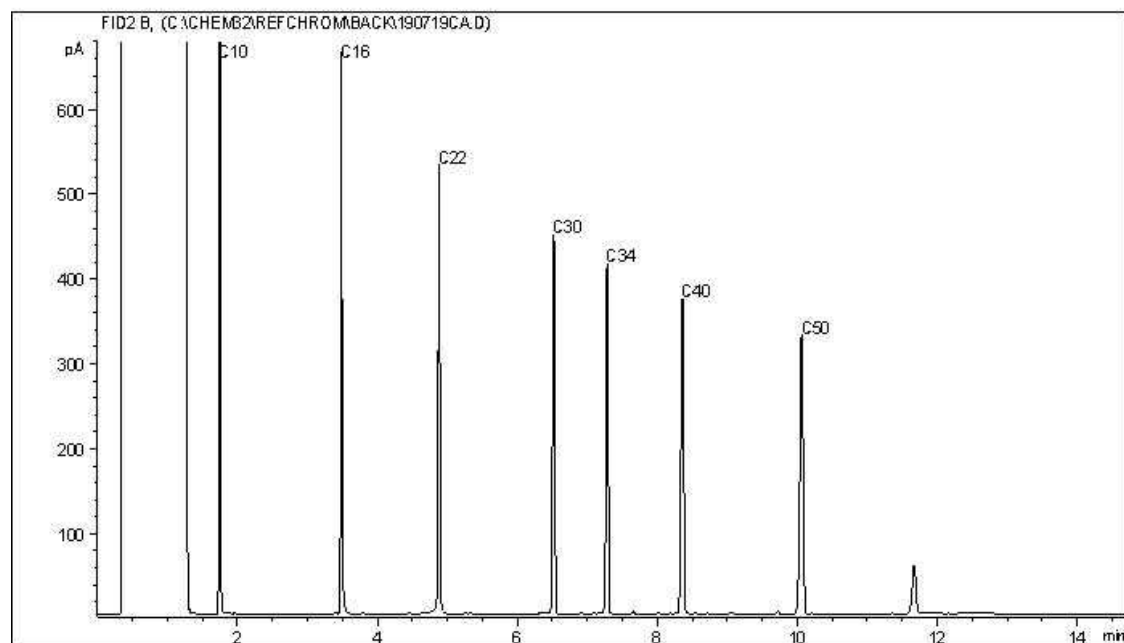
# CCME Hydrocarbons (F2-F4 in water) Chromatogram

Instrument: GC7

## TYPICAL PRODUCT CARBON NUMBER RANGES

Gasoline:	C4 - C12	Diesel:	C8 - C22
Varsol:	C8 - C12	Lubricating Oils:	C20 - C40
Kerosene:	C7 - C16	Crude Oils:	C3 - C60+

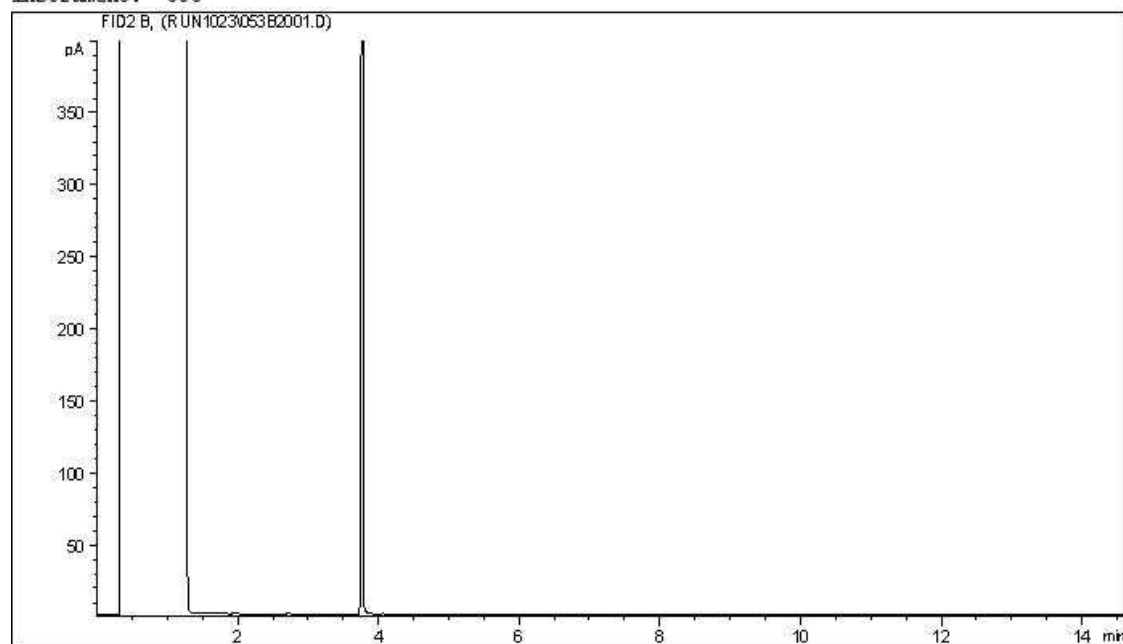
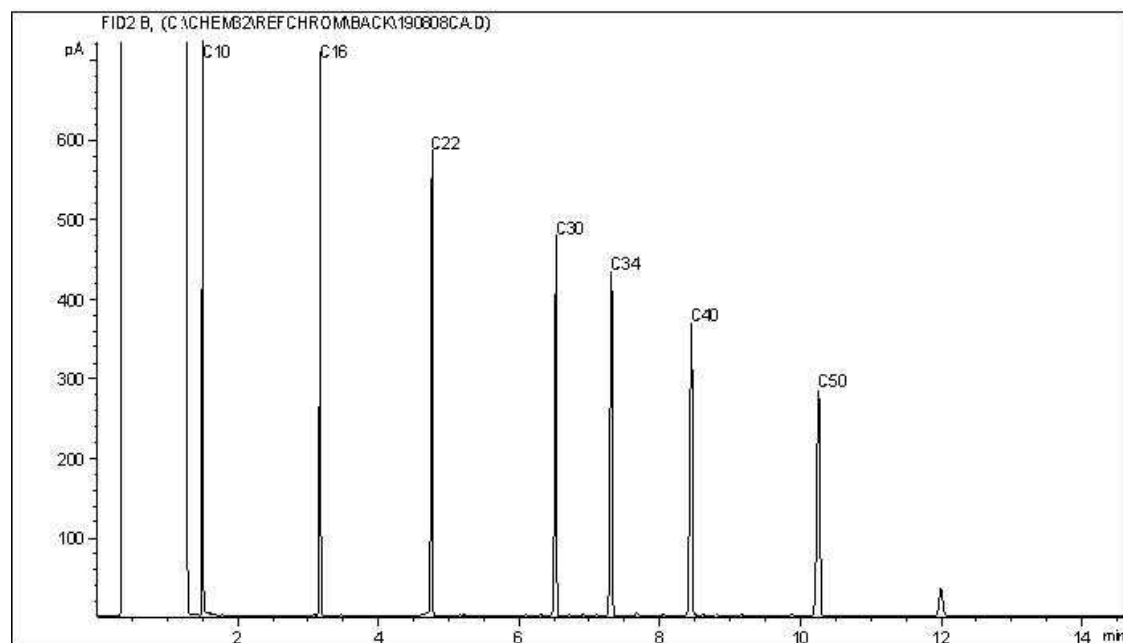
### CCME Hydrocarbons (F2-F4 in water) Chromatogram

Instrument: GC6

#### TYPICAL PRODUCT CARBON NUMBER RANGES

Gasoline:	C4 - C12	Diesel:	C8 - C22
Varsol:	C8 - C12	Lubricating Oils:	C20 - C40
Kerosene:	C7 - C16	Crude Oils:	C3 - C60+

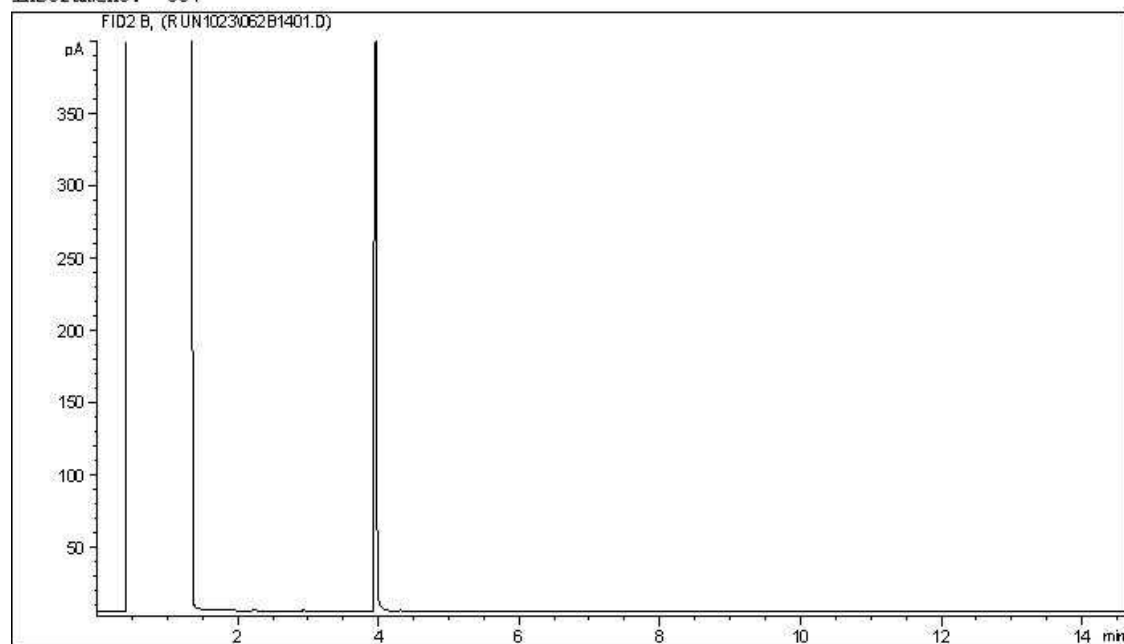
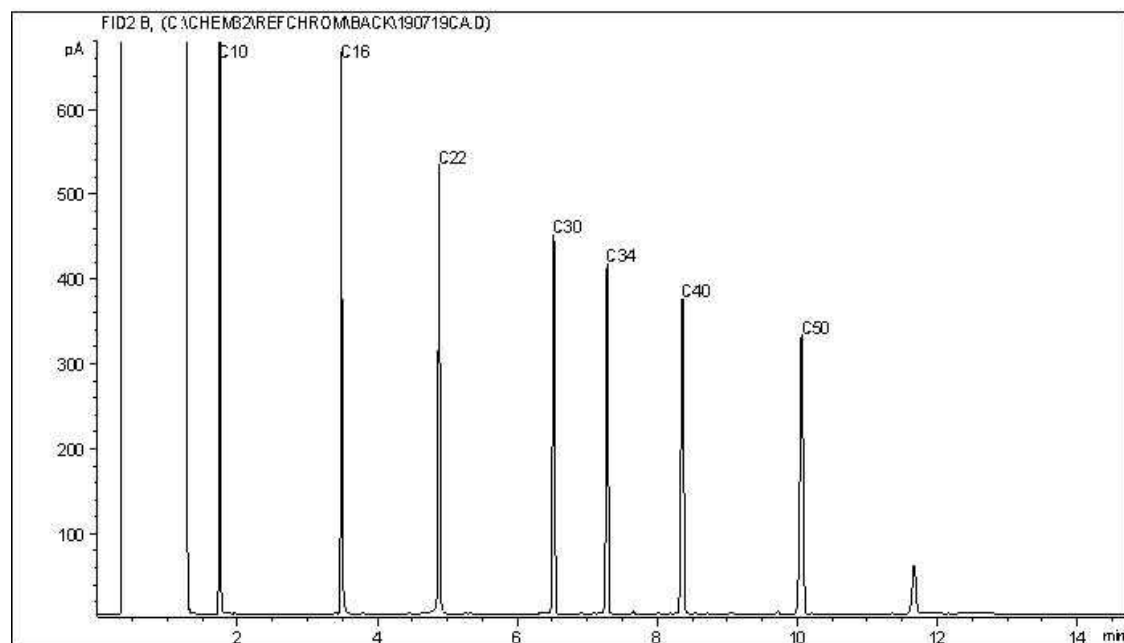
# CCME Hydrocarbons (F2-F4 in water) Chromatogram

Instrument: GC7

## TYPICAL PRODUCT CARBON NUMBER RANGES

Gasoline:	C4 - C12	Diesel:	C8 - C22
Varsol:	C8 - C12	Lubricating Oils:	C20 - C40
Kerosene:	C7 - C16	Crude Oils:	C3 - C60+
