Remediation Monitoring

568 Gunn Road
Winnipeg, Manitoba

Trademark Properties

October 1, 2021

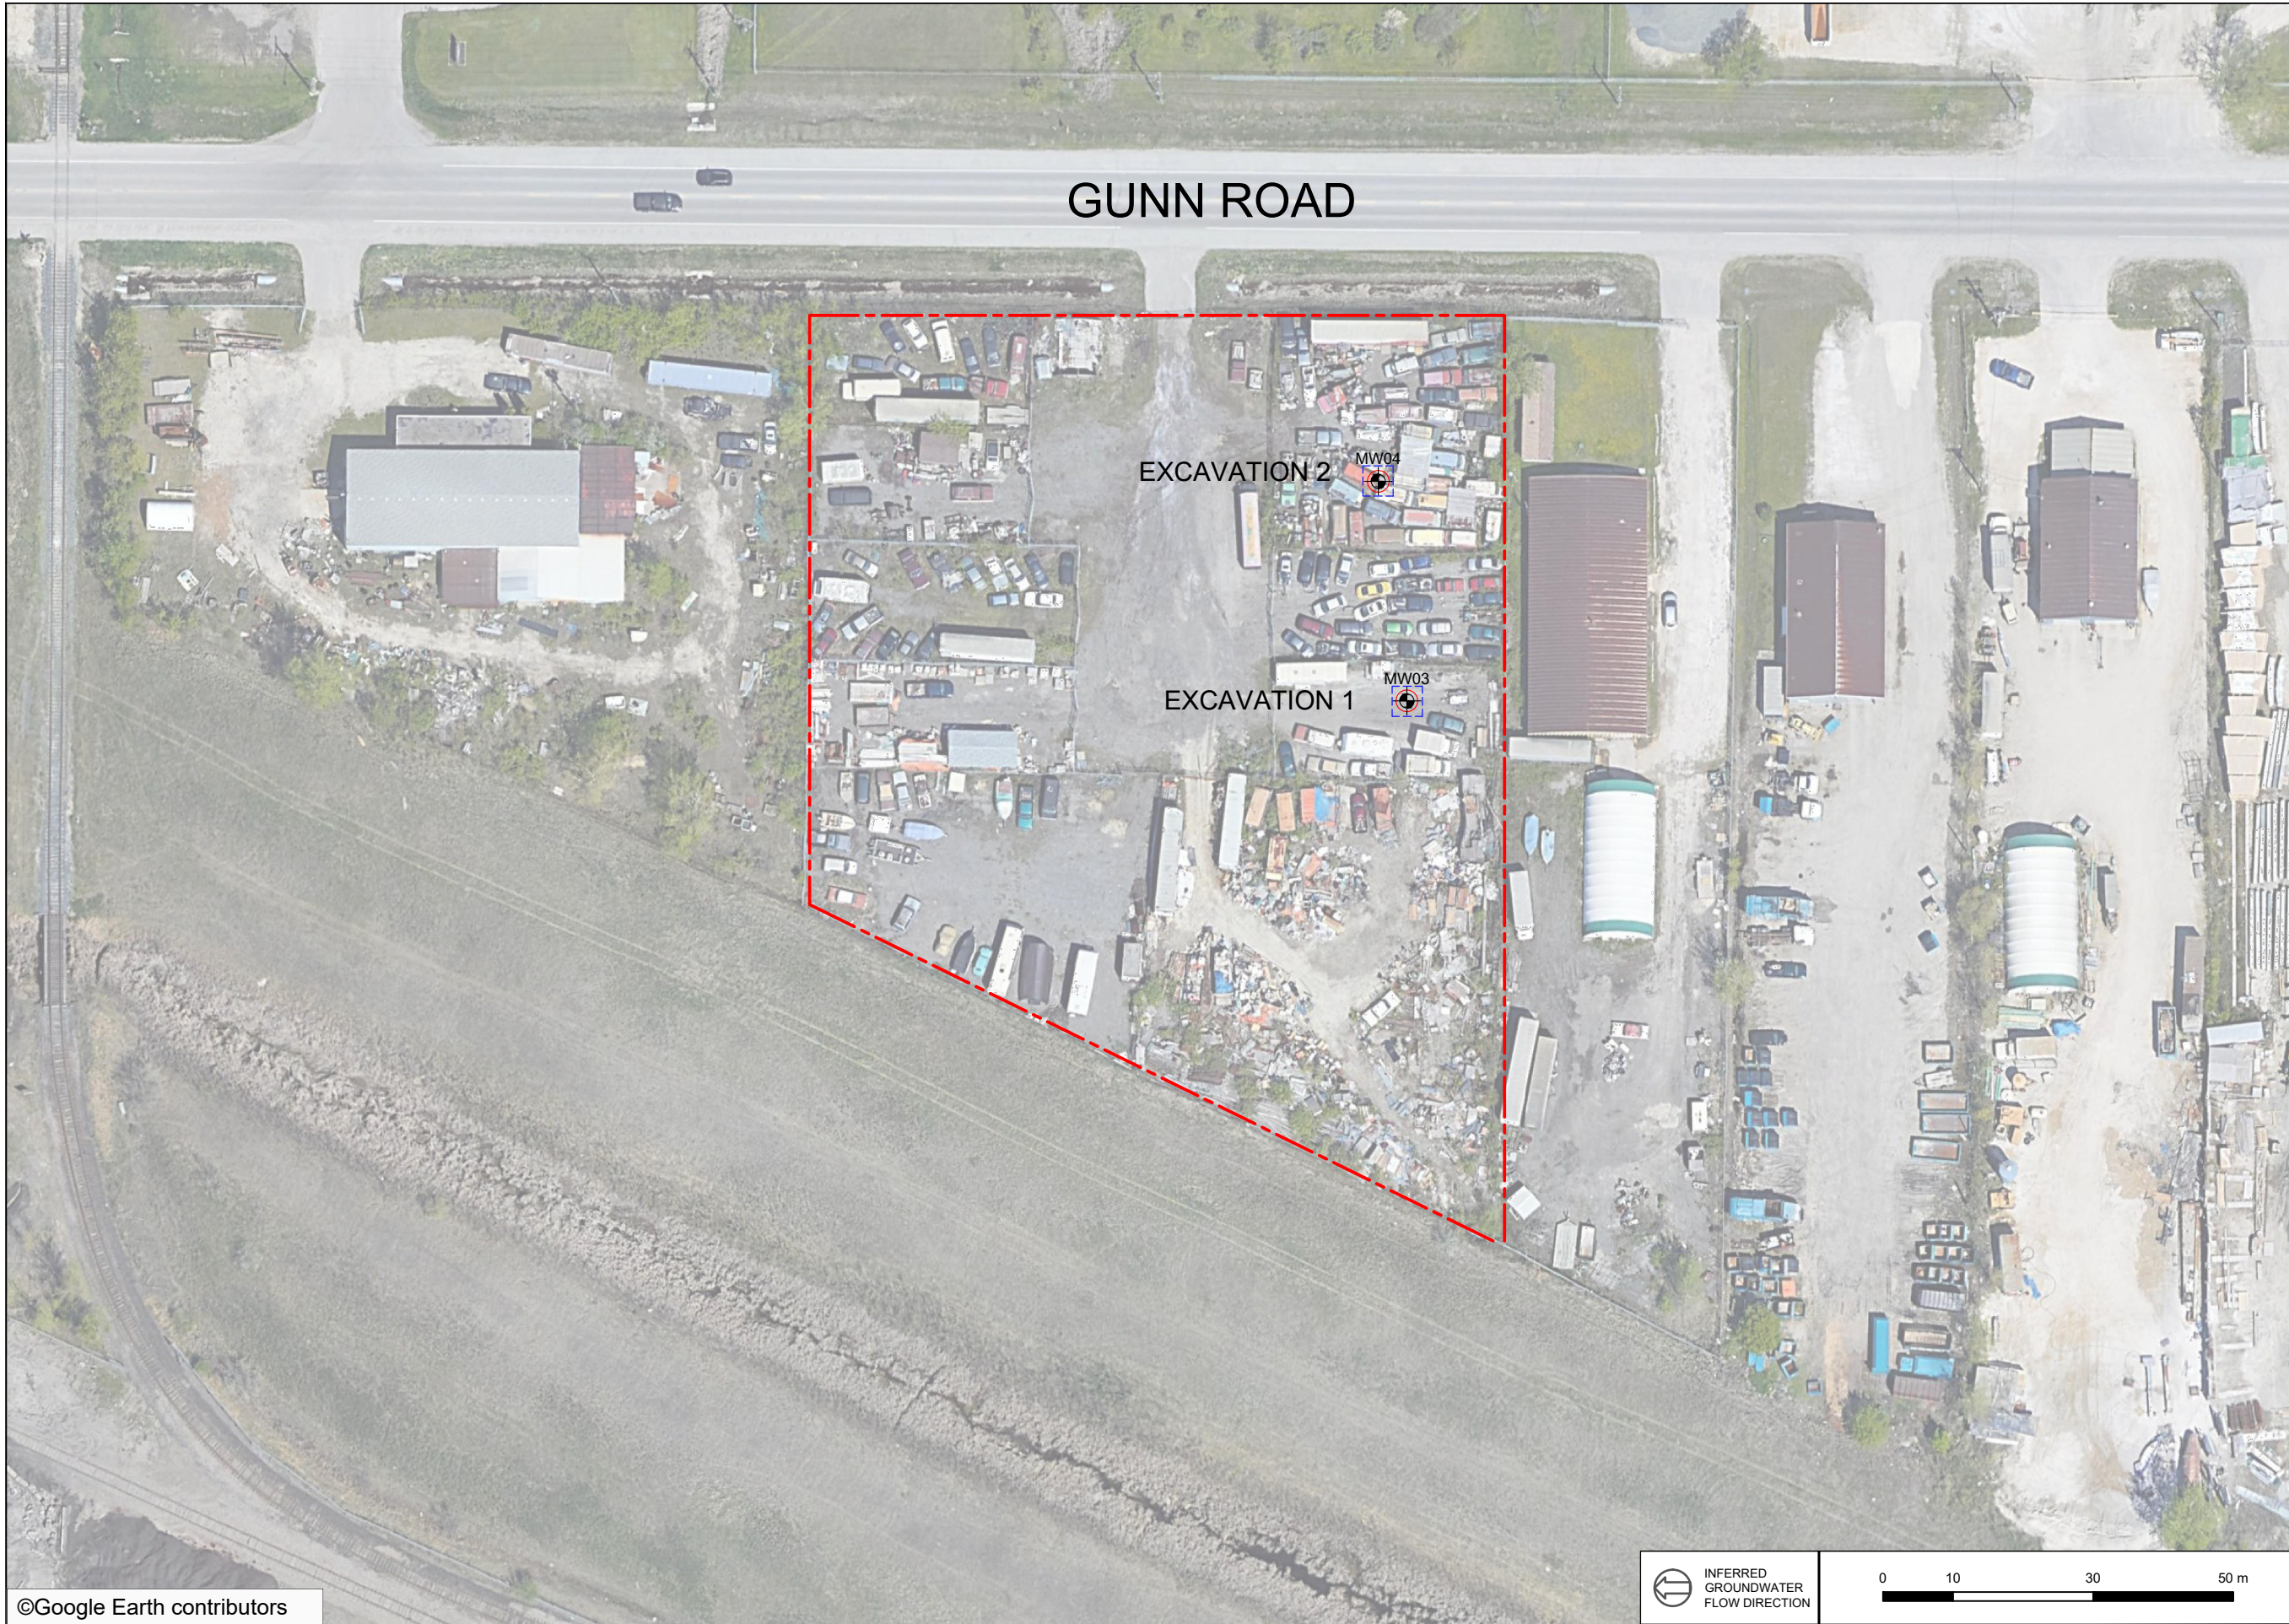
GUNN ROAD

EXCAVATION 2

The location of the boreholes with identified metal impacts are presented on Figure 2.

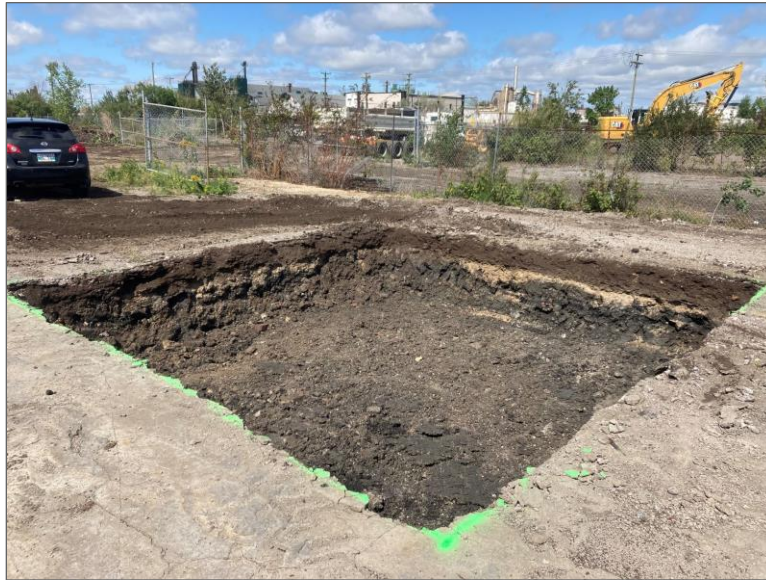
Photo 1 – Excavation 1 dimensions prior to re-excavation.

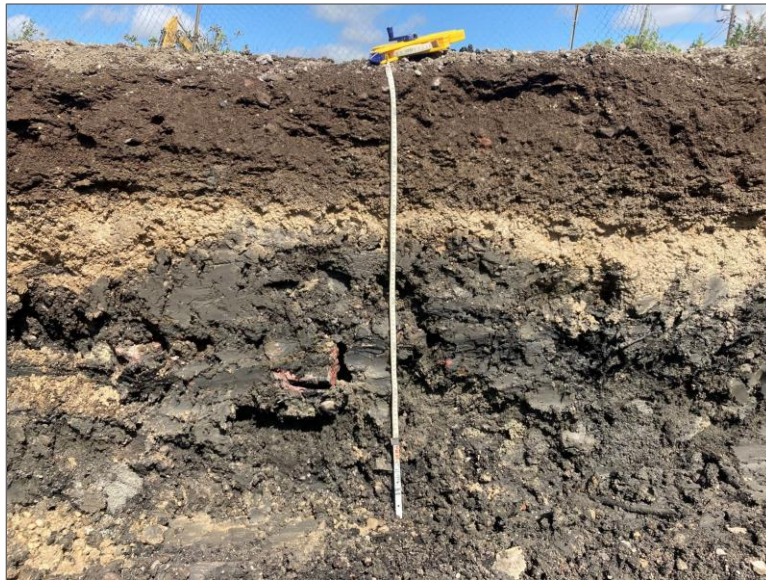
Photo 2 – Soil stratigraphy at Excavation 1 extending to 1 metre below ground surface.

Based on observations of soil conditions during the Remediation Monitoring activities, the soil stratigraphy within the excavation below the gravel surface generally consisted of fill material comprised of brown gravel, sand, silt, and debris followed by brown to grey silty clay, gravel and debris to a depth of approximately 1 mbgs.

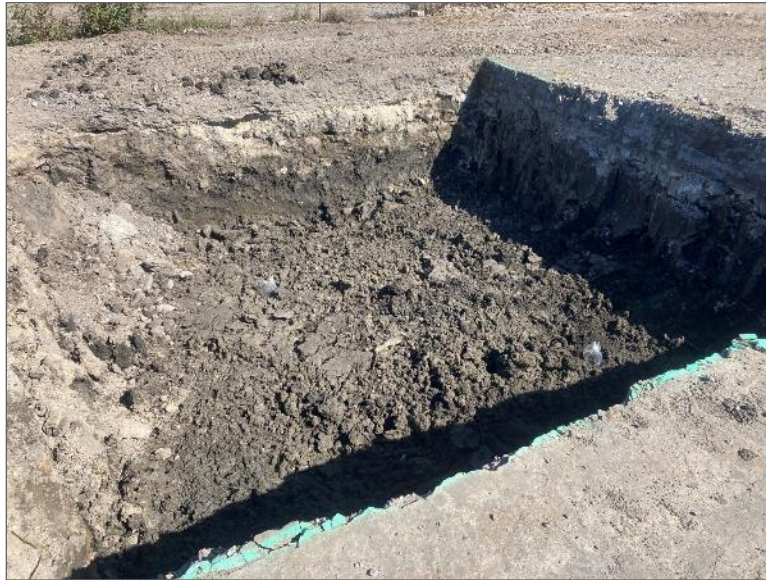
Photo 3 – Excavation 1 final limits after re-excitation.

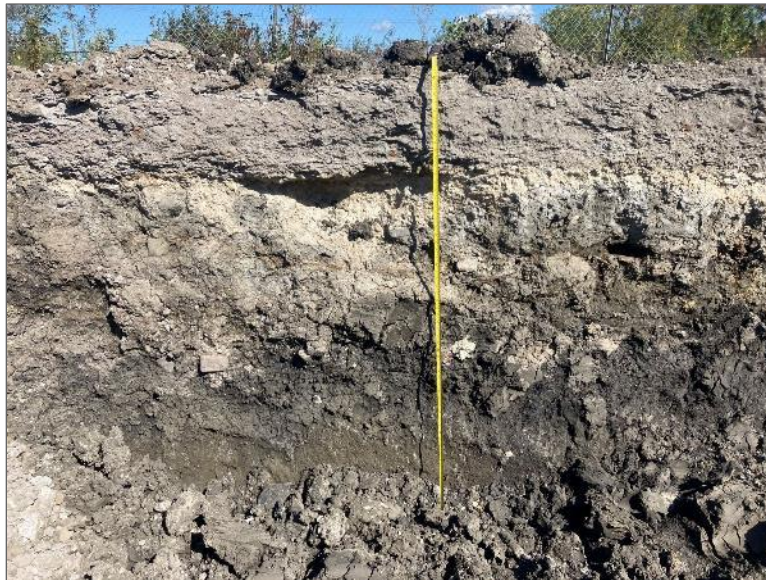
Photo 4 – Soil stratigraphy at Excavation 1 extending to 1.5 metre below ground surface.

Native subsurface material underlying the fill material was observed to generally consist of brown silty clay that extended to the maximum excavation depth of 1.5 mbgs.

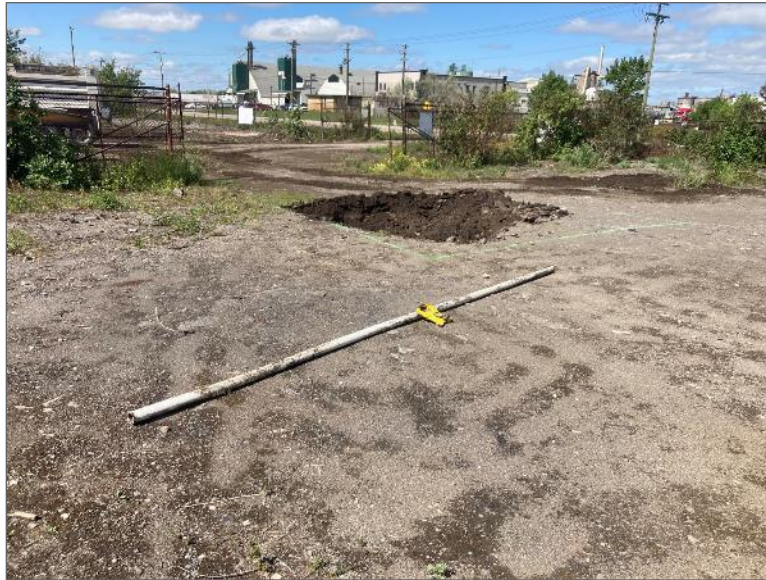
Photo 5 – PVC pipe from former monitoring well MW04 in Excavation 2.

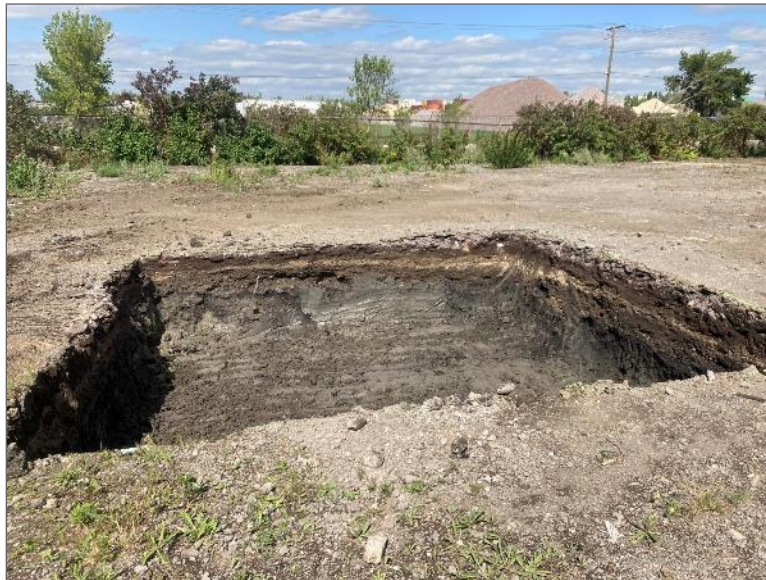
Photo 6 – Excavation 2 final limits.
