REMEDIATION PROGRAM

Loss Location: Highway 391, approximately 12 km north of Nelson House, Manitoba

Pario Project Number: 45629-199

Date of Report: June 1, 2023

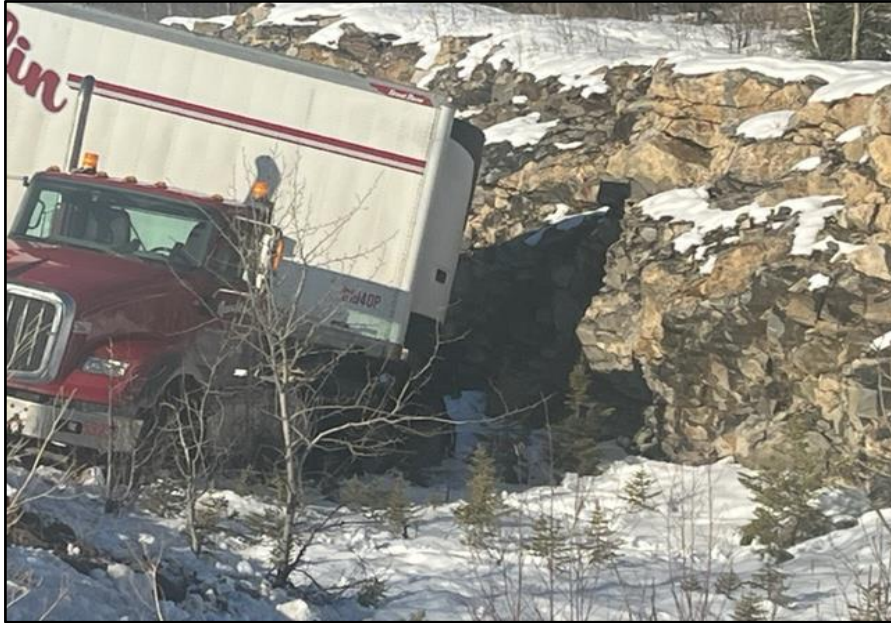
Photo 1: Looking north across incident site prior to vehicle recovery. Third-Party supplied photo.

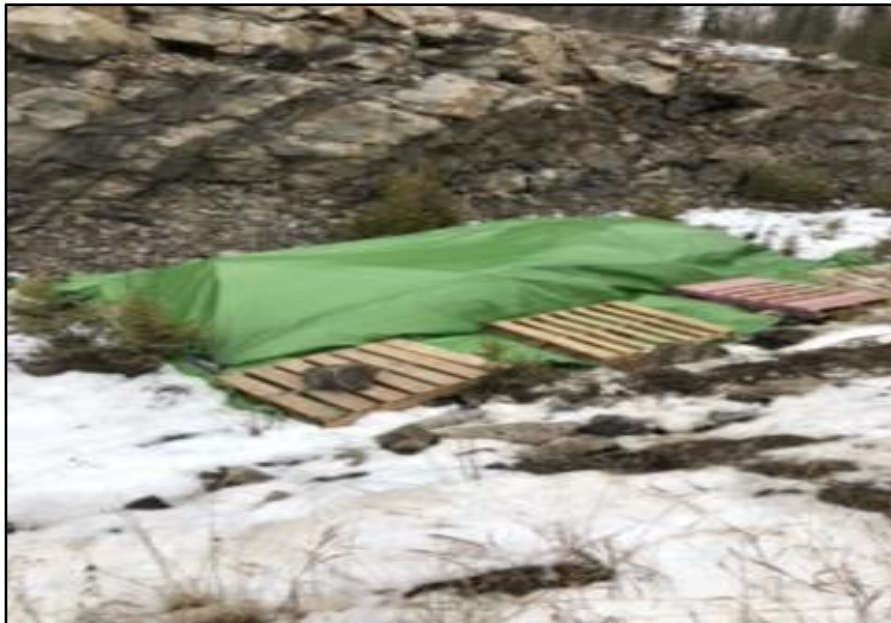
Photo 2: Looking north across site prior to excavation showing covered impacted material. Third-Party supplied photo.

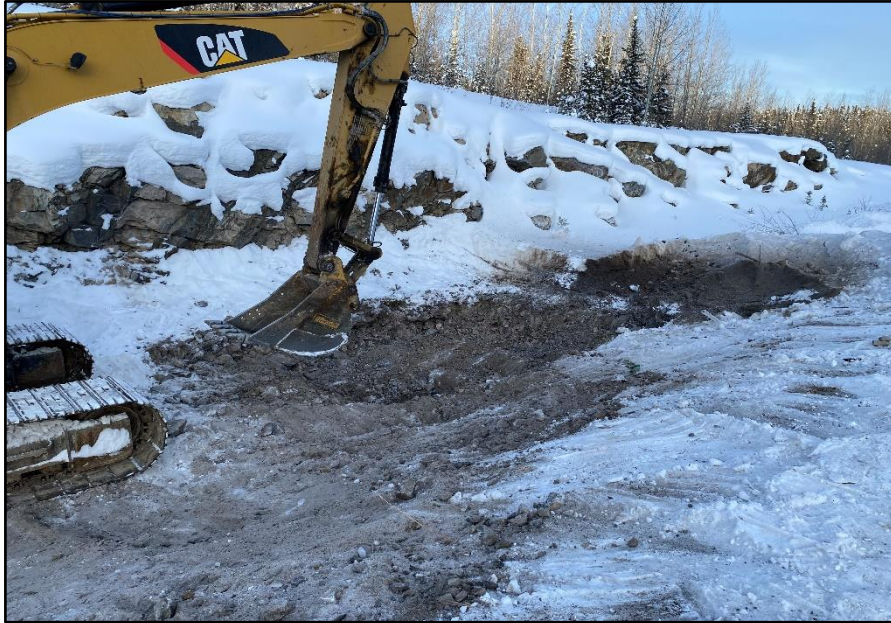
Photo 3: Looking northeast across site showing excavation extents.

- The completed remedial excavation measured approximately 17.5 m² and extended to a maximum depth of 0.5 m below grade. A total of 27.75 Kg of contaminated soil was excavated and disposed of at the receiving landfill on January 31, 2023.

On January 31, 2023, Pario retained local contractors to provide the necessary manpower and equipment to excavate the contaminated material. The excavation of contaminated soil was directed using physical evidence of contamination and field screening for organic vapour concentrations (OVCs) using an Eagle II photoionization detector (PID). Confirmatory sampling was conducted on January 31, 2023. The limits of the remedial excavation were measured to be 5 m by 3.5 m (at widest point) to a maximum depth of 0.5 mbgs. A total of 27.75 tonnes of contaminated soil was transported and disposed at the City of Thompson, Manitoba landfill facility on January 31, 2023.

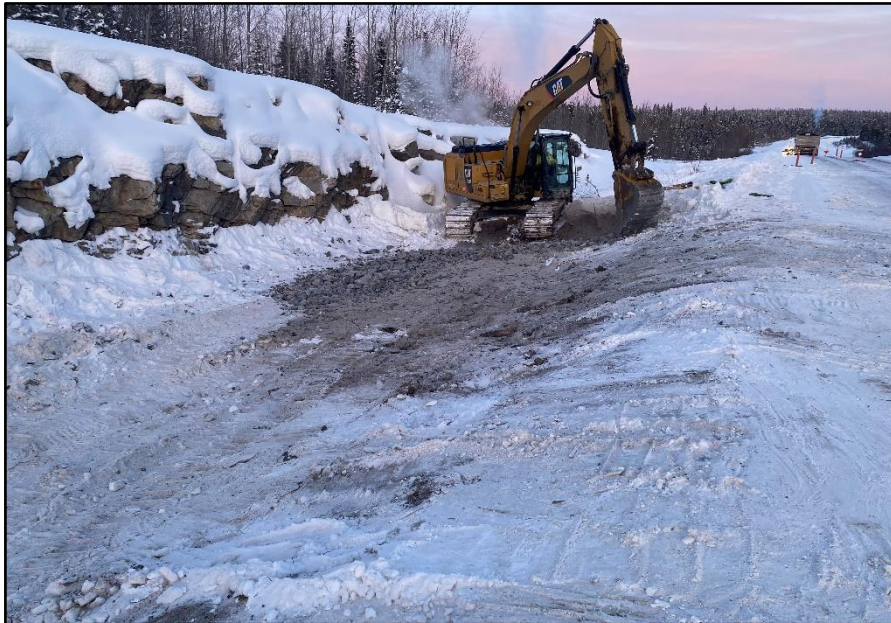
Photo 4: Looking east across site after backfilling.

The excavation was backfilled with blast rock to match pre-spill conditions. Given the limited depth of excavation, the soil was compacted using the equipment on Site. Final backfilling of the Site was conducted on January 31, 2023. Topsoil and seed are not required at Site.
